Defects of modern wood windows – examples of expert reports

JERZY PŁOŃSKI

Building Research Institute, Building Structures Department

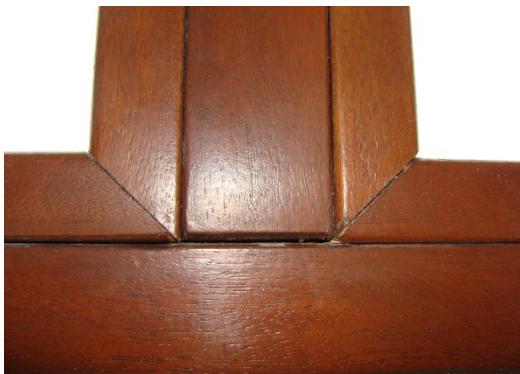
Fig. 1. Incorrectly jointed window

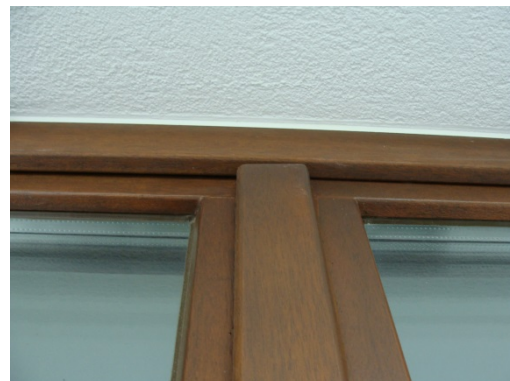
Fig. 2. Incorrect joint between the window frame and the post

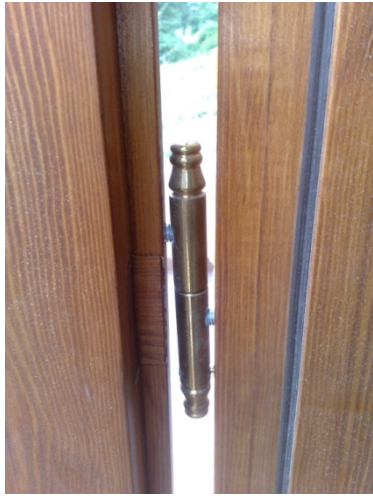
Fig. 4. Improper hinge

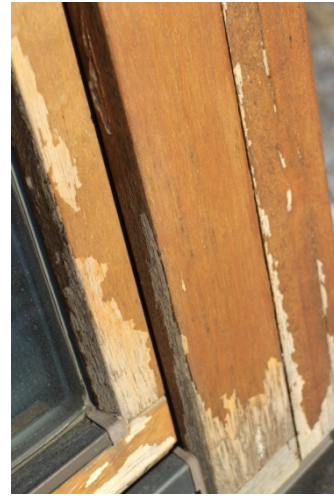
Fig. 5. Badly made protective coatings

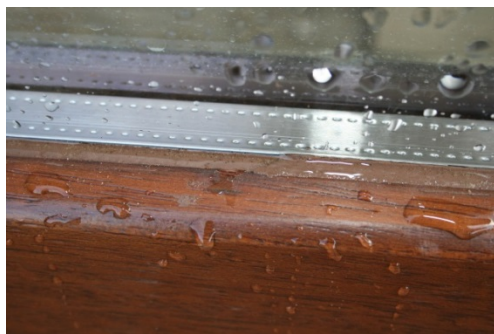
- The windows were installed before completion of the wet works on site. During these works, there was excessive air humidity at the temperatures of 6–8°C, and the rooms were not properly ventilated – the forced ventilation was not put into operation yet at this point. Also the air diffusers were closed. Due to very high humidity, moisture was condensing on the cold walls (leading to development of fungi), headers and window frames, and also on the window components – glazing along the aluminium frames, sash bars and hardware. This led to moistness of the woodwork frames and more excessive condensation of moisture; the measurements indicated wood humidity exceeding 30%.

Fig. 5. Moisture condensation on the windows installed before completion of wet

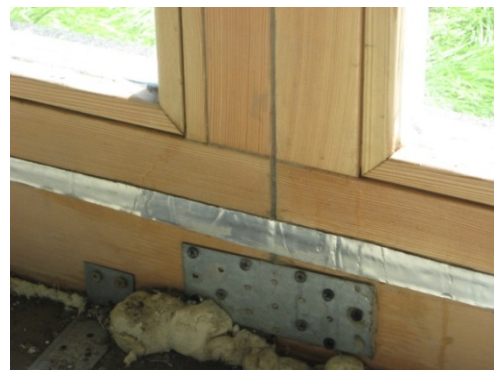
Fig. 6. Incorrect installation and sealing of adjoining windows
