Design and execution risks of safety of the structure made from glued laminated timber

GENERAL DESCRIPTION OF THE STRUCTURE

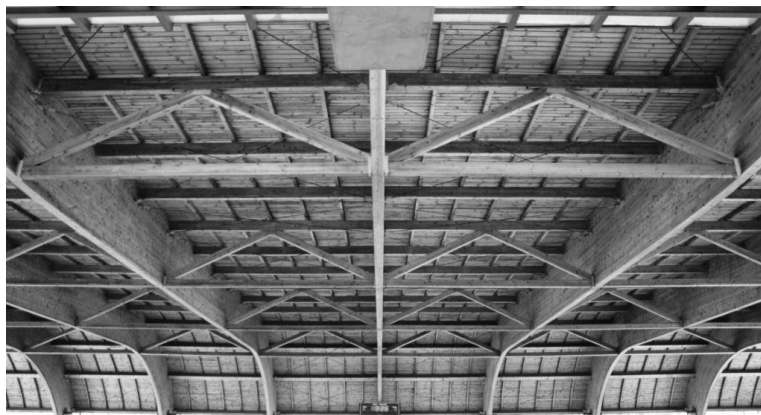
Figure 2. View of the roof stiffenings

- e) unfavorable for the girder solution of the stiffener made as a K-type lattice (Fig. 2), which results in the transfer of the considerable high forces from the stiffener ($2 \times$ of approx. 11 kN) to the bottom part of the girder. This results in the excessive tension perpendicular to the wood grains; these stresses sum up with tensional stresses perpendicular to the grains in the curvatures of the girder.

4. Stiffening of the structure with use of the K-type lattice is faulty. This inappropriate solution has a negative influence on the main girders and results in the excessive tensile stresses perpendicular to grains. To prevent this phenomenon, suspension of the bottom chord of the K-type lattice stiffener to the purlin is necessary.

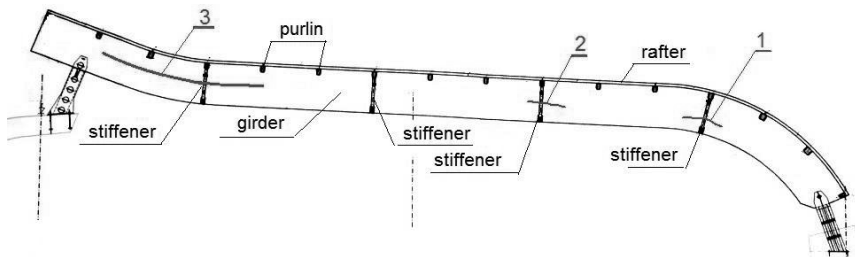
- c) on the side edges of a few girders, the longitudinal cracks were observed; the examples of the main cracks are shown in the Fig. 3; in many cases, the cracks were observed nearby the top support of the girder and the top arch (marked No. 3 in Fig. 3); the cracks appear approximately at mid height of the girders and extend to the longitudinal stiffener of the structure. Similar cracks were present also in the place where the rectilinear part of the girder changes into bottom arch (marked No. 1 in Fig. 3) also in the area of the longitudinal stiffeners. In a few girders they were observed longitudinal cracks also in the rectilinear part of the girders, in the area of the longitudinal stiffeners (marked No. 2 in Fig. 3).

Figure 3. View of the exemplary longitudinal cracks with their localization

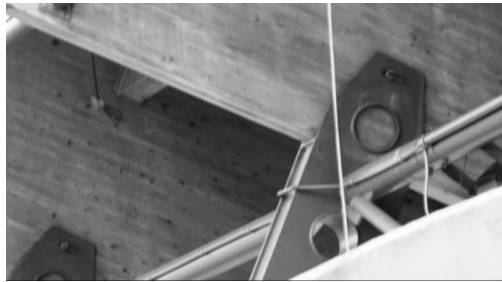
- d) permanent displacements of the girders were registered on the top, sliding support (under assumption that the bolts were mounted centrally in the elliptical hole with a length equal to 150 mm); the value of displacements varies and for the side girders equals between 1-2 cm and increases to the 5-6 cm for the girders in the central part, where displacement is the highest (Fig. 4).

Figure 4. Displacement of the central girders on the top support
