LONG-TERM PERFORMANCE OF EXTERNAL THERMAL INSULATION SYSTEMS (ETICS)

Helmut Künzel, Hartwig M. Künzel, Klaus Sedlbauer
Fraunhofer-Institute for Building Physics, Holzkirchen, Germany

Key words: external insulation, durability, façade inspection, maintenance effort

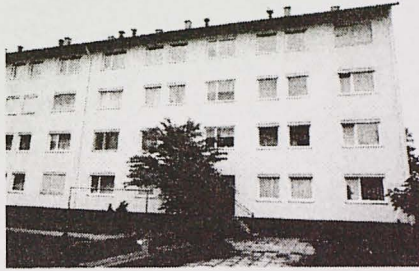
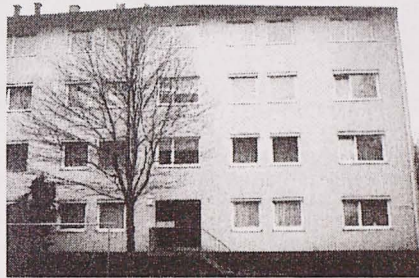
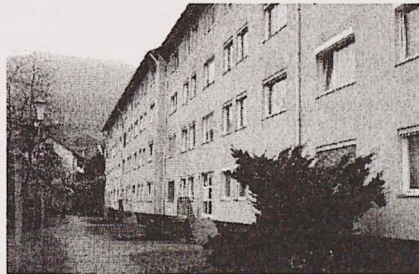
Figure 2 shows the northern façade of object 52 (residential building in Geislingen) at three different times. Despite variations in the quality of the photographs, no important or harmful change is to be observed over a period of 23 years. On the western sides of parallel located residential buildings in Geislingen (objects 30 to 33), however, partial development of algae has occurred. It is remarkable that the algae growth did not change within the period between the two inspections (Fig. 3). The neighbouring object,

Fig. 2. Northern façade of object 52 in Geislingen at three different times: 2, 14 and 23 years after refurbishment in 1981 from slightly different angles. The slowly growing conifer can be seen in all photographs; the deciduous tree was cut before 2004

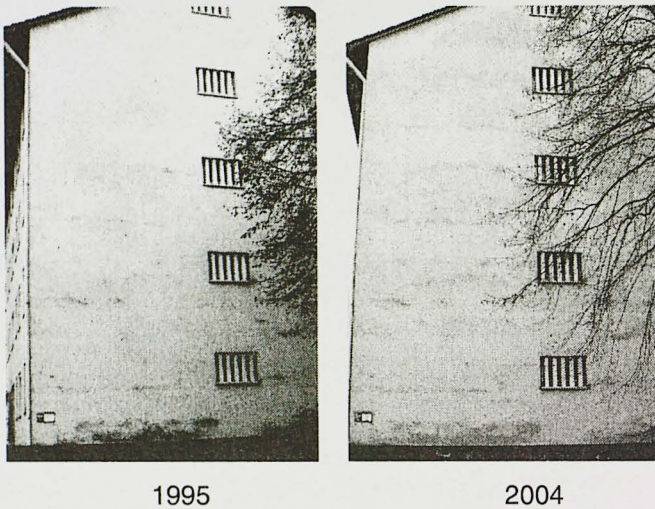
Fig. 3. Western gable side of object 31 in Geislingen 14 years (left) and 23 years (right) after refurbishment in 1981 with algae growth in the plinth area and some horizontal stripes, caused by irregularities in the plaster structure in relation with the working levels of the scaffold. The tree has grown visibly; the algae infestation remained unchanged with a slight increase in the upper façade area

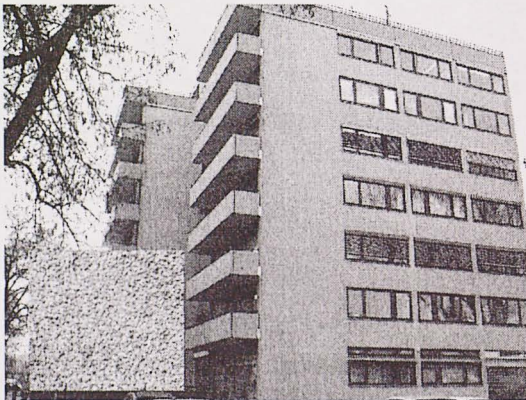
Figure 4 shows the eastern and southern façades of object 54 in Neumarkt. The evenly spread pollution provided a kind of patina within a period of 16 years. On the northern façade (adjacent to the road) of object 51 in Nuremberg no microbial growth occurred after a first refurbishment by applying a coating 17 years ago. In this case, the cleaning effect prevails due to the drainage of rain water, concentrating between the windows (Fig. 5).

Fig. 4. Eastern and southern façade (from right to left) of object 54 in Neumarkt in December 2004, 16 years after refurbishment in 1988 by applying a new coating, close-up view of the plaster at the small window

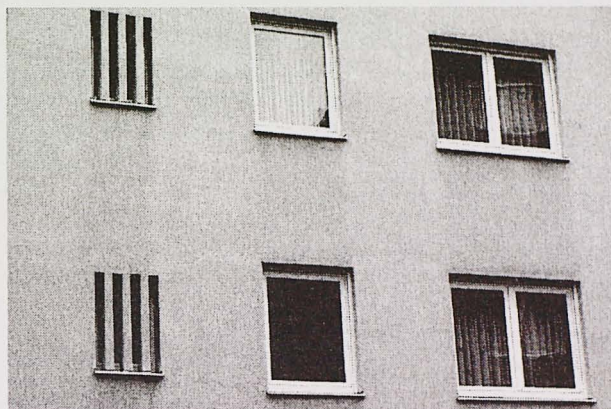
Fig. 5. Partial view of the northern façade of object 51 in Nuremberg, 17 years after refurbishment by applying a new coating in 1987. The areas between the windows, which are exposed to intense rain, are somewhat lighter, meaning that the exposure to rain did not cause the growth of algae but had a cleaning effect

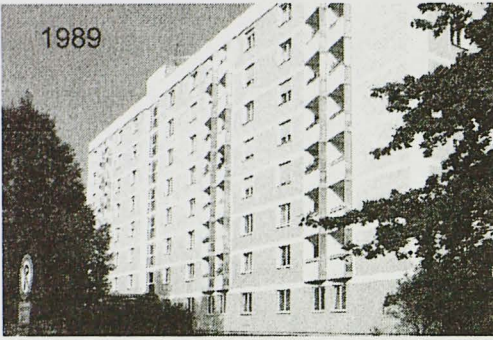
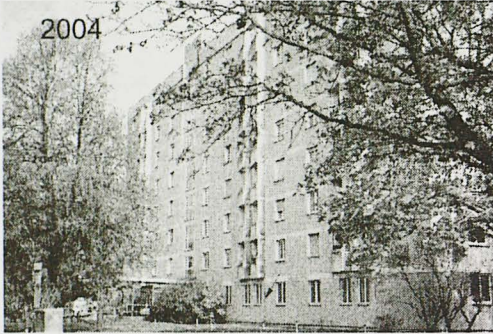
The state of the western façade of object 16 (old people's home in Munich) in 1989, three years after the application of an ETICS, is documented by Figure 6 above. There were no visible defects. But during the inspection in 2004, 15 years later, algae growth could clearly be observed (Fig. 6, below), especially in areas with a intense exposure to rain (Fig. 7).

Fig. 6. Western façade of object 16 (old people's home in Munich) in September 1989, three years after application of an ETICS and another 15 years later in November 2004 (the difference in colour does not mean that the façade has been repainted, it is due to coloration problems with digital photography). The formation of algae is clearly visible especially in areas intensely exposed to rain (see arrow and Fig. 7)

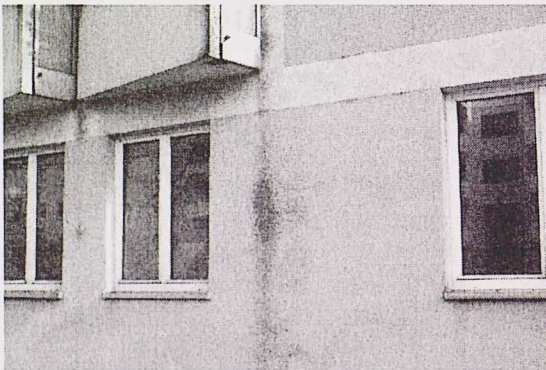
Fig. 7. Local growth of algae along areas with a concentration at the rain water runoff path, caused by the lateral limitation of the balconies and the wind. The growth of algae is clearly smaller in the area immediately below the balcony plate than in the unprotected wall areas

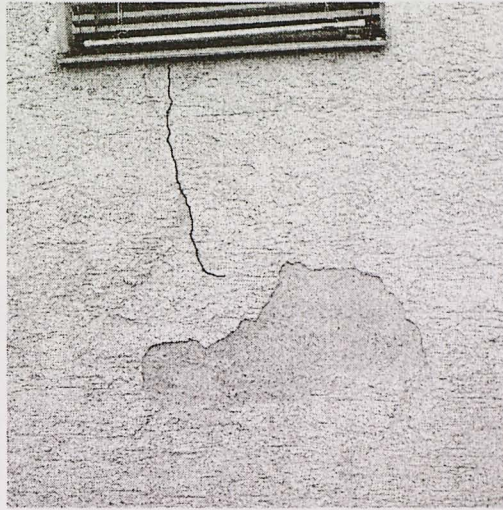
Fig. 8. Crack in the wall and damage of plaster on the western façade of the neighbouring building of object 32 without an External Wall Insulation System (Ebertstraße 2). A crack in the wall below the window is occurring in the plaster. The final rendering has partially separated from the undercoat plaster. Such damage can generally be avoided by means of a thermal insulation composite system with the help of the de-coupling effect of the soft insulation layer as well as plastic additives and the reinforcement of the plaster

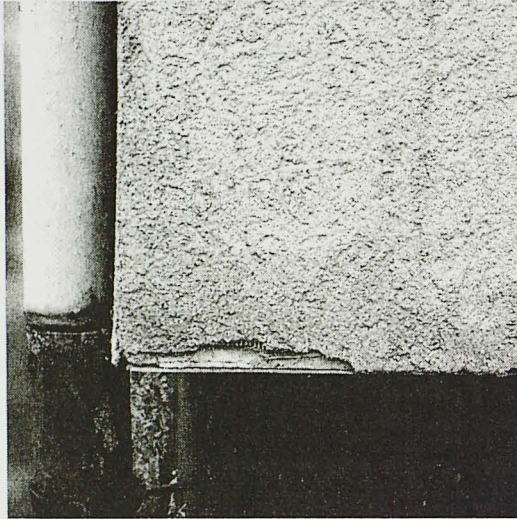
Continuous maintenance is necessary for the façades of buildings. It is not only necessary to renew the façade coating due to pollution and weathering from time to time, but also to check and repair the “weak spots“ on all façades, where necessary. Such weak spots may be connections around windows or façade connections as shown in Figure 9.

Fig. 9. Example of a damage in the lower area of the façade on the western side of object 31 by permeation of moisture at the connection profile (maybe influenced by a defective rain-water pipe). Such damages should be repaired early enough and separately from other general façade refurbishments
