## **Selection of drone flight parameters for determination of post-disaster forest area profile based on aerial photographs**

**Abstract:** *Selection of drone flight parameters for determination of post-disaster forest area profile based on aerial photographs.* One of the main applications of unmanned aerial vehicles (UAV) is observation from the air of areas which are difficult to access. In forestry, this particularly concerns post-disaster areas with wind-fallen, wind-thrown and partly burned trees. The aim of the study was to assess usefulness of aerial photographs taken with a Microdrones MD4-200 drone from the point of view of detailed analysis of a wind damaged area. Investigations which allowed determining methodological requirements concerning the flight parameters and drone settings were carried out in a test area, whereas the verification investigation was performed on actual post-disaster areas. They constituted the basis for development of methodological guidelines regarding the use of drones for the assumed method of describing post-disaster forest areas.

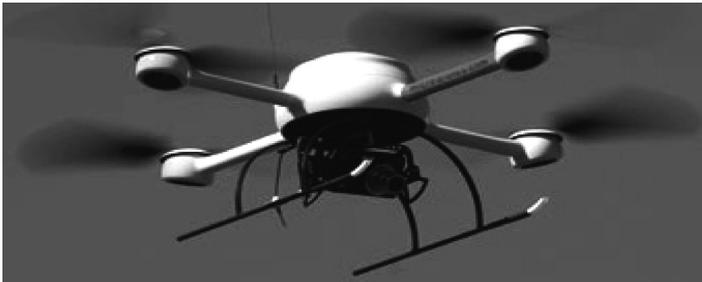
FIGURE 1. Microdrones Md4-200

The investigation was carried out using a Md4-200 drone (Fig. 1), manufactured by Microdrones GmbH, serial number 433.

Its low load capacity (up to 200 g) allows fixing of a small photographic or film camera, but its small dimensions and weight allow easy transport nearby the post-disaster area. It may be used for photographing various objects, e.g. buildings, trees, water reservoirs, etc. Table 1 presents basic technical parameters of Microdrones Md4-200 UAS.

The main disadvantage of the device is short flight time on one battery and the need to land the device and replace the battery.

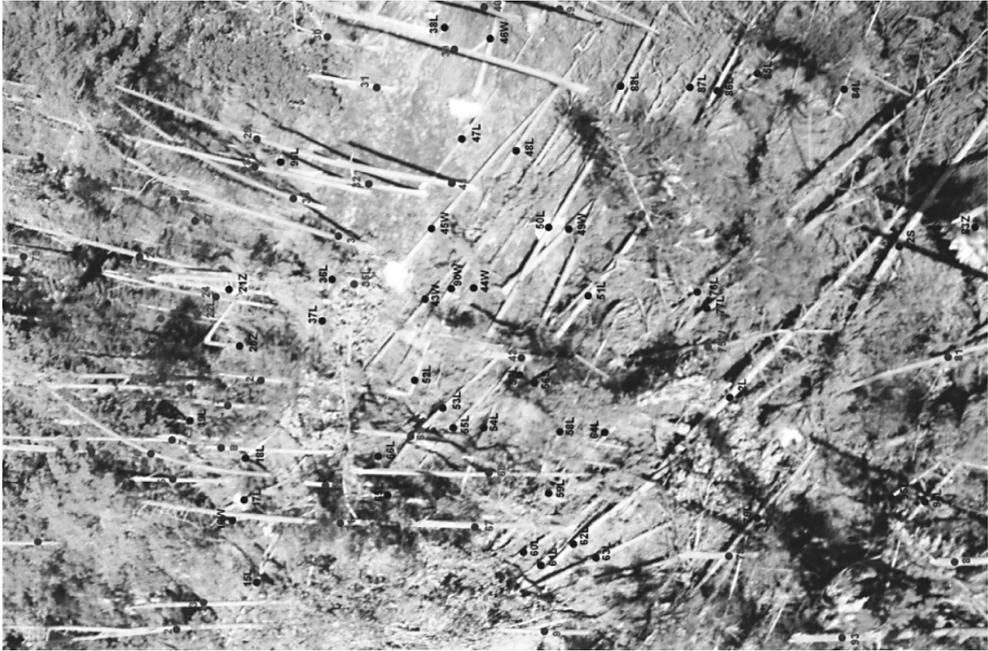
FIGURE 6. Post-disaster forest area in Opoczno Forest Inspectorate (altitude: 30 m, wind speed: 2.4 m/s)

Results of the test investigation were verified on actual post-disaster areas. The investigation was carried out on a wind-damaged area in Opoczno Forest Inspectorate of the Regional Directorate for State Forests in Łódź. Series of photographs presenting tree stands in Białaczów Forest District, in section 108bc were taken, at the following flight altitudes: 30, 40, 60, 80, 100 and 120 m, at the average wind speed of 2.4–3.1 m/s. An example of a photograph taken during the investigation at a real post-disaster area is presented in Figure 6.

Particular kinds of damage to trees on perpendicular photographs were identified as follows: X – standing tree, L – lying part of a wind-fallen tree, Z – standing part of a wind-fallen tree, S – pile-up of trees, W – wind-thrown tree. This, together with identification of the direction of tree position, allowed determining the profile of a post-disaster area. An example profile is presented in Table 3.
