Large-size mechanically joined timber structure subjected to short-term and long-term load

Abstract: *Large-size mechanically joined timber structure subjected to short-term and long-term load.* The article presents laboratory test results of a large-size timber structure joined with mechanical joints, subjected to static load considering the duration of the load application. The results obtained indicate the potential limitations in applying such solutions despite such advantages as the ease of installation, dismantling possibility, repeatability of components and relatively easy matching to various shapes.

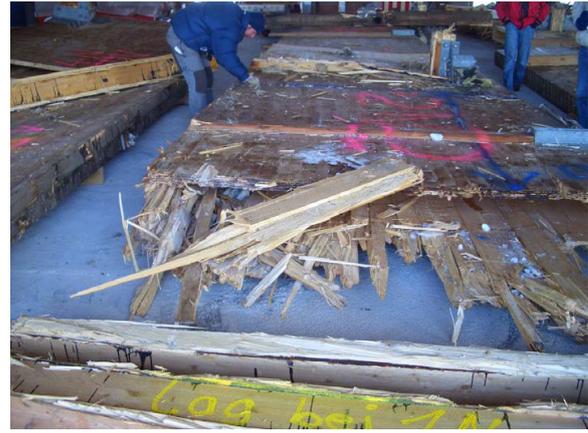
Fig. 4 Damaged general girder joint after collapsed roof structure in ice-arena in Bad Reichenhall [7]

Timber is one of the first construction materials used over generations in this part of Europe. After learning the basics of woodworking, timber was initially used in carpentry structures. It has been used in structural engineering since the invention of mechanical joints and sufficiently durable adhesives. The turning point was the introduction of laminated wood which alleviated most of the drawbacks found in solid wood (such as knots, size limitations), allowing at the same time creation of much larger structures, often with complex geometry (Fig. 1, 2). Literature devoted to such structures is very elaborate, ranging from theory and technology descriptions [1], [4], behaviour of individual components e.g. beams [3], durability problems [5], recommendations for use [2] and predicted use [6]. Despite such broad knowledge available, also in case of such structures, problems are faced, mainly due to delamination of the components (fig. 3) or even disasters in extreme cases [7] (fig. 4).

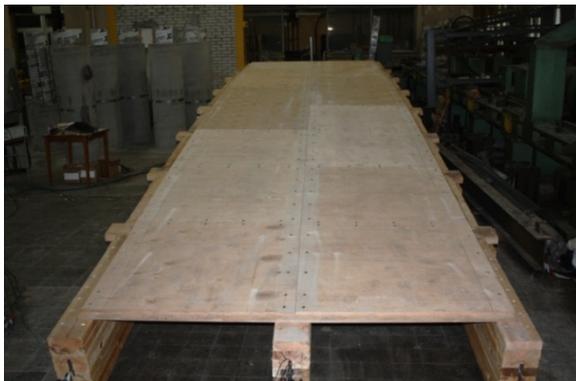
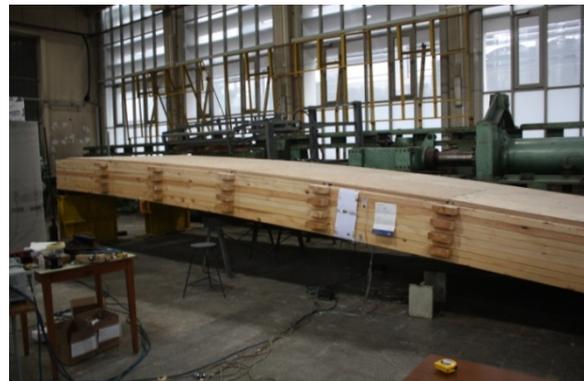
Fig. 5 Component at the test rig

The timber component tested was a section of roofing structure of a sports and entertainment arena being designed. The component comprised a load-bearing grid composed of three trusses spaced 1.25 m and length (in projection) 10.36 m, divided by seven transoms in 1.25 m centres. The trusses were arc shaped with 0.3 m rise and were made of 8 beams, 4 of which were continuous over the entire truss length, 4 beams were split (filling between transoms). The dimensions of the truss and transom boards were 60 x 200 mm. The beams were joined with $\varnothing 10 \times 120$ mm screws in 140 to 275 mm centres (shorter spacing at the trusses' ends). The trusses and transoms were mechanically joined with M26 tapped bolt. The tested component was covered with two layers of 2 x 22 mm plywood screwed to the grid. The grid was made of C27 class pine wood according to the declaration of conformity provided by the component manufacturer. The component at the test place is shown in Fig. 5.

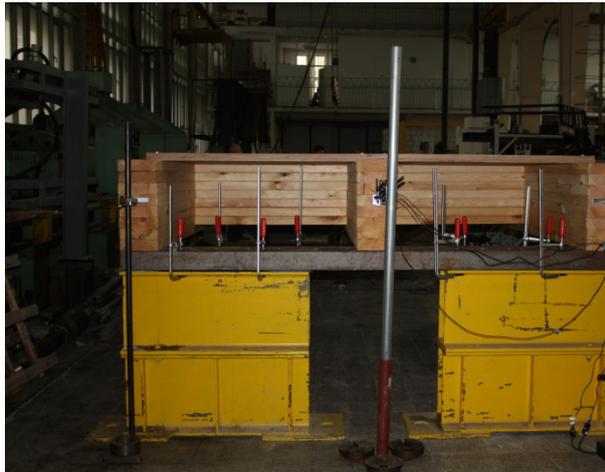
Fig. 6 Lifted side of the tested model

In order to correctly represent the model performance in relation to the structure under design, one side of it was lifted to the height 1.0 m (Fig. 6). The support was provided by articulated joints at the lower edge of the trusses. In addition to that, at the lowered side sliding bearings of teflon plates were installed (Fig. 7).

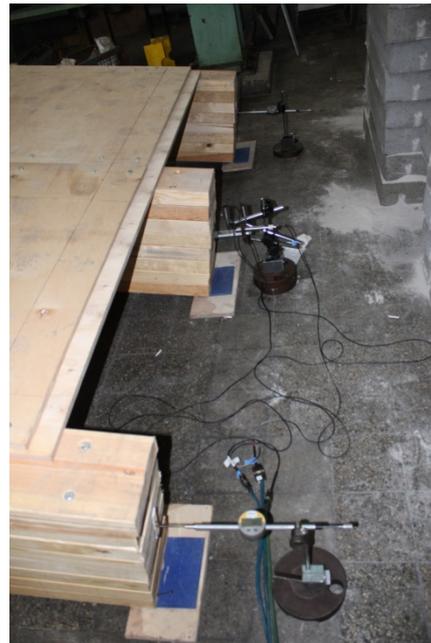
Fig. 7 Lowered side of the model

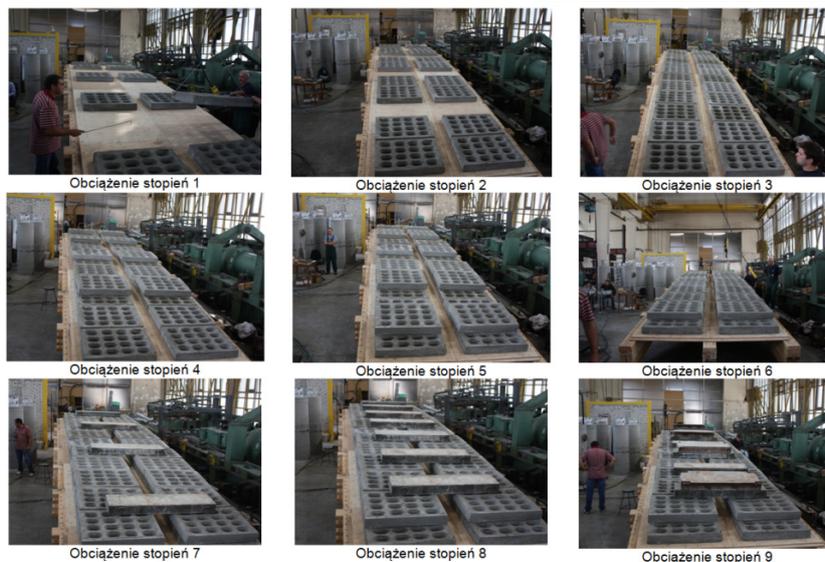
Fig. 8 Photographic documentation of individual loading steps/stages

The tests were carried out to determine strength parameters of the model of timber structure joined with mechanical joints, with plywood sheathing. The component was tested until the load 5.0 kN/m was achieved in relation to the middle truss (w1) and 2.5 kN/m in relation to extreme trusses (w2). The load was applied by gravity with reinforced concrete slabs with dimensions 1.0 x 0.75 x 0.12 m and weight from 134 kg to 143 kg and steel and concrete beams with dimensions 1.5 x 0.35 x 0.15 m and weight from 251 kg to 335 kg. The tested mode was loaded in nine stages, applying the load in a uniform manner. Photographic documentation of individual layers is shown in Fig. 8.

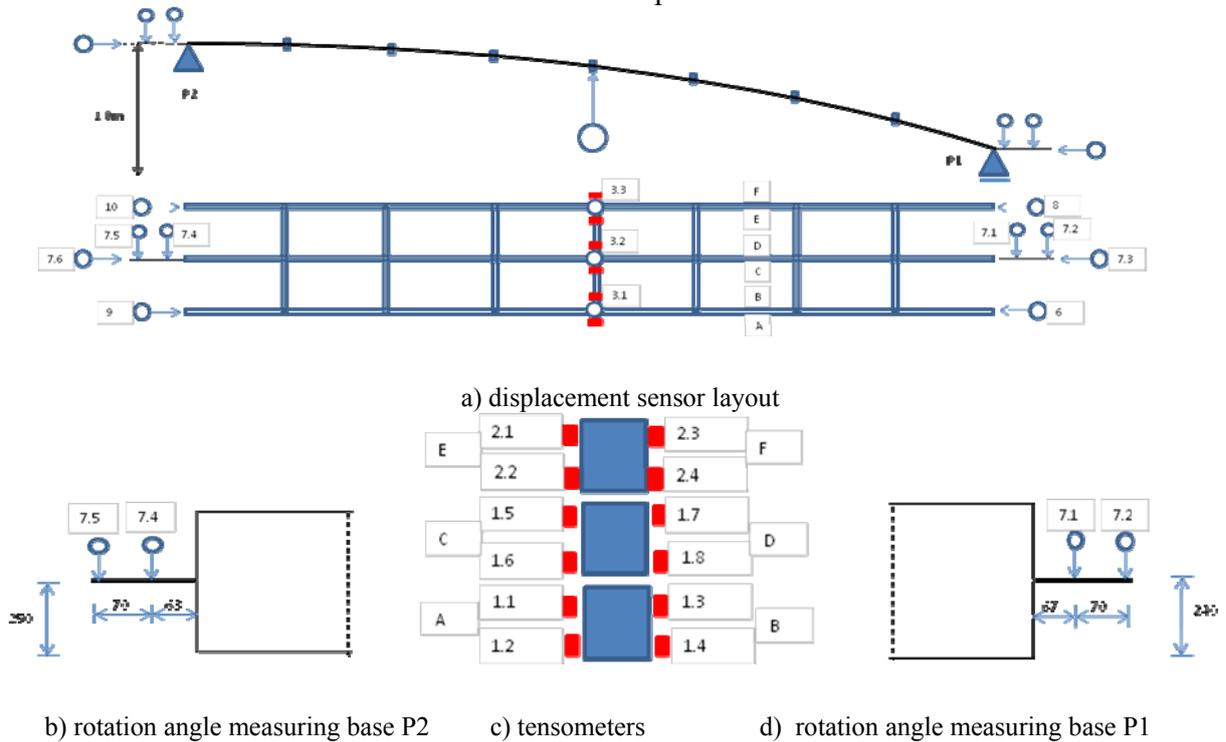
Fig. 9 Location of the displacement sensors and tensometers

Induction sensors were installed to measure the displacement. 50/120 LY41-4L-10M type tensometers were used to measure the deformation. Figure 9 shows the layout of sensors and tensometers and basic dimensions for determining the rotation angle. The tensometers were bonded on the girder sides and located at the extreme continuous belts, i.e. on the bottom truss belt and on the second one from the top.

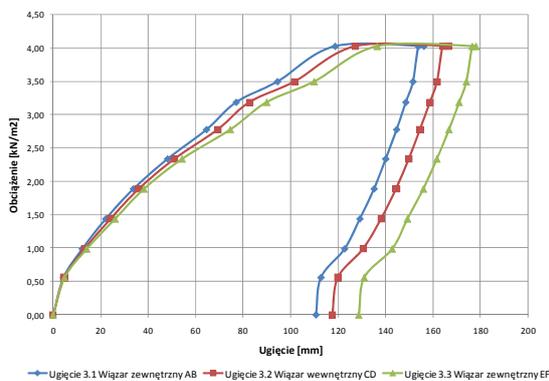
Fig. 10 Deflection vs. surface load

The result of the measurements was the flexure (Fig. 10), horizontal support displacement (Fig. 11) and rotation angles vs. the surface load.

Outside the linear flexure-load relationship (above 2.34 kN/m^2), the flexure vs. load characteristics becomes non-linear with clear disturbance at the load level 2.78 kN/m^2 to the maximum of 4.03 kN/m^2 . After 10 hours of maintaining the maximum load and gradual relieving of load from the model, the offset of the load-flexure relationship is clear as compared to the increasing load. At the end phase of loading, at the level 1.44 kN/m^2 to 0, anomaly was found in the stress direction, i.e. only compressive stress occurred vertically.

1. Within the load range up to level 5, i.e. 2.34 kN/m^2 , the load and stress is close to linear in nature. Structure flexure, depending of the load (except for the pre-load) is of linear character, with the average matching factor $R = 0.9905$. Above the level 5, non-linear relationships occur.

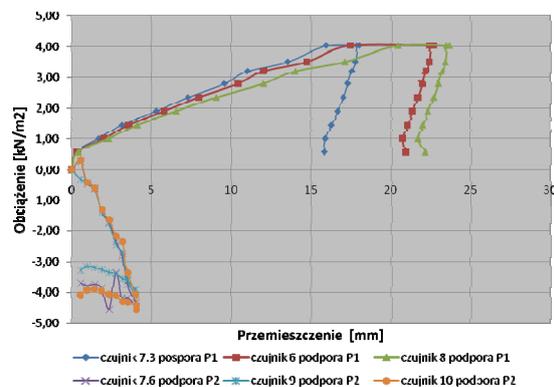
Fig. 11 Longitudinal displacement of supports vs. surface load

Permanent displacement of the supports:

- support P1 truss (AB): 20.9mm, (CD): 15.8mm, (EF): 22.9mm,
- support P2 (lifted) truss (AB): 3.3mm, (CD): 3.7mm, (EF): 4.1mm

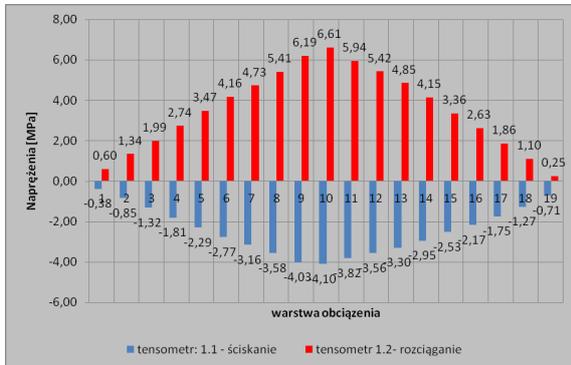
Fig. 12 Stress – outer truss side A

The curves (Fig. 12, 13) show the stress in MPa depending on the load level. The load levels are denoted with continuous numbering in the curves. Numbers 1 to 10 corresponds to loading a component, numbers from 11 to 19 to relieving load from the component after 10 hours.

2. The stress distribution in relation to the increased load, in all instances, was close to linear in nature. The location of the neutral centreline, in case of each girder, is shifted above the geometric centre of the truss, towards the sheathing. This proves that the sheathing is also activated.

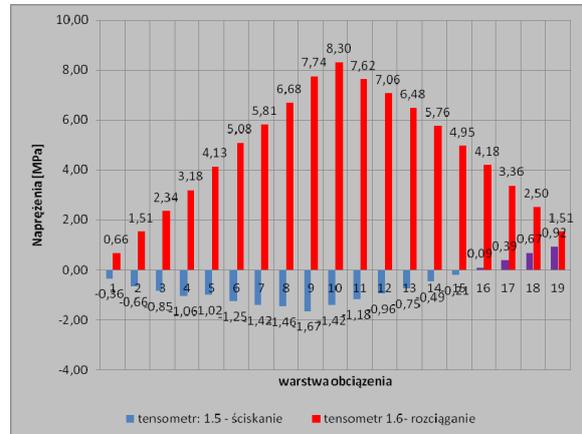
Fig. 13 Stress – inner truss side C

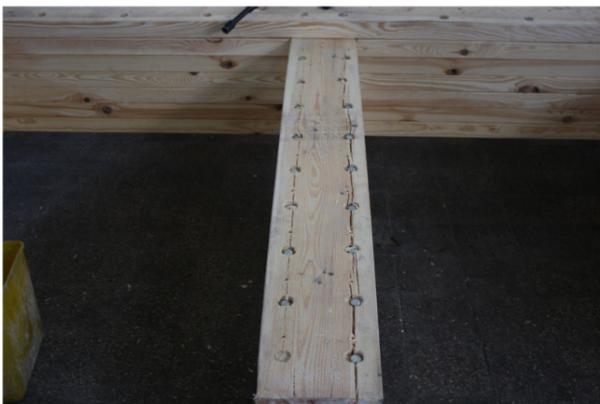
Fig. 14 Longitudinal beam cracks – top view

No sheathing damage was found after the tests. After removing the sheathing while removing the truss, longitudinal cracks were found in the beams (Fig. 14, 15). Beam cracks are present in the support area. The cracking occurred in the following areas:

- outer truss (AB): beam 2, 3 and 5 from top (the sheathing side);
- inner truss (CD): beam 3 from the top;
- outer truss (EF): beam 3 and 5 from the top.

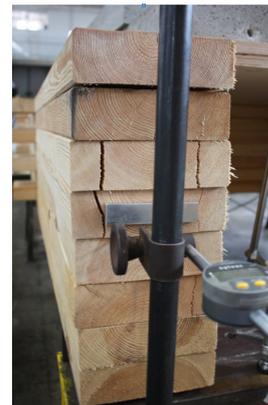
Fig. 15 Longitudinal beam cracks from the beam front
