Traditional ornaments of Świdermajers' style windows in the town of Otwock

Abstract: The paper provides an analysis of windows in antique Świdermajers' style wooden buildings, located in Otwock. It has been discovered that many of them have been already replaced with new ones. Attention was paid to the traditional Polish casement window structure with transom and the main part below, additionally divided into smaller areas by wooden horizontal or vertical muntins. Analysis of traditional window carpentry elements such as shutters, window sills, cornices and batten frames was made together with their classification based on different kinds of decorative motifs.

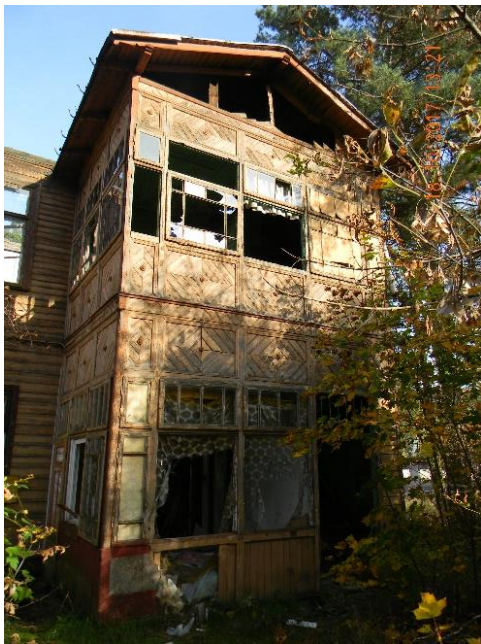
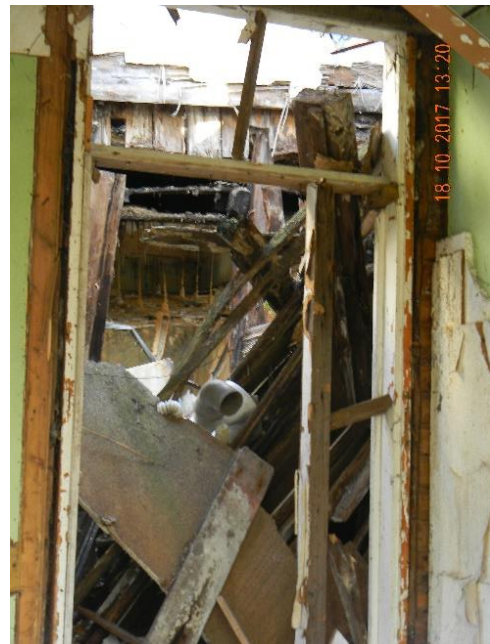
Figure 1. Ruined building at Kościuszki 29 Street: A- veranda, current state, B- collapsed ceiling inside.

Currently in Poland, wooden buildings are becoming archaic, and antique wooden buildings often lack proper care and restoration, becoming scarcer and scarcer every year (Fig.1). Hence the importance of protection, documentation and research of the buildings that still do exist, which sometimes entails protecting them against over-conservation by zealous owners. Such conservation undertakings often include restoration of façades, with unnecessary removal of antique stucco work, door and window carpentry, stairs and floors.

Out of the 80 buildings under research, 74 were still inhabited, 5 were in good technical condition but empty, and only 1 building was ruined (Fig.1). Total 36 of them had all their original windows, and 23 buildings had both old and new windows. Because the buildings were inhabited by many families, there would be different sets of windows within the same building: original windows in one area, new wooden windows in another, and also plastic windows. Unfortunately, the high number of 20 houses had only modern windows, and in some cases the owners preserved the original window field divisions (Fig.2).

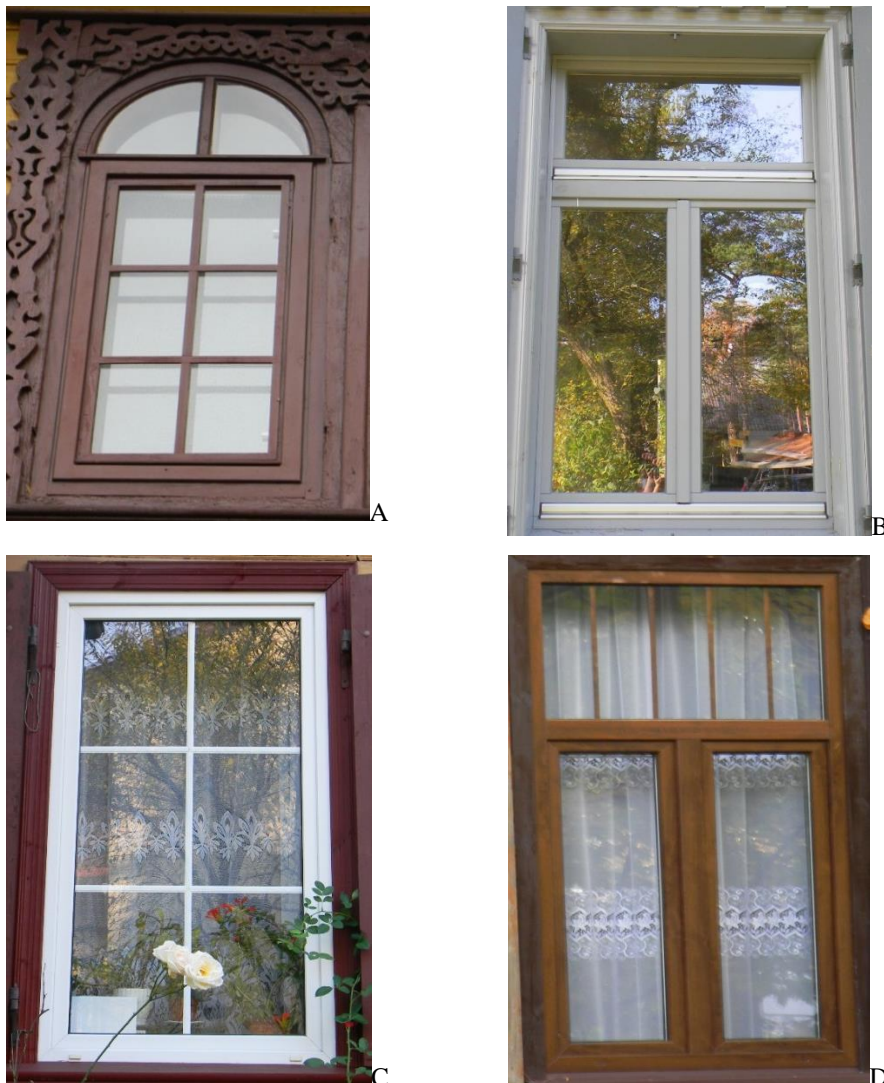
Figure 2. New windows made in traditional style in buildings at: A- Kraszewskiego 101 (No.31), B- Lelewela 7 (No.33), C- Poetycka 5a (No.59) and D- Kościuszki 7 (No.24)

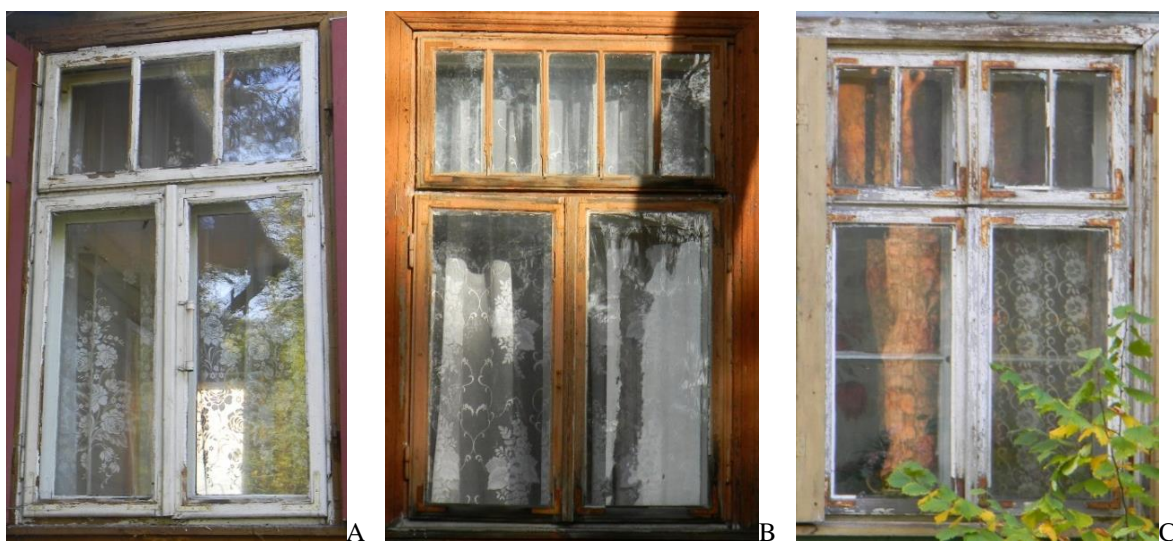
Figure 3. Windows with muntins above the transom A- Kołłątaja 29 (No.16), Kościuszki 7 (No.24), Słoneczna 8 (No.69)

In the preserved antique windows of wooden Świdermajers' buildings, the transoms were also shifted upwards. Additionally, usually only in the external casements, in the transom part (Fig.3) or both above and below the transom (Fig.4) cross or vertical muntins were applied, quite densely close to each other. It was an attempt to optically reduce the size of the big glass pane, by adding a grid of mullions.

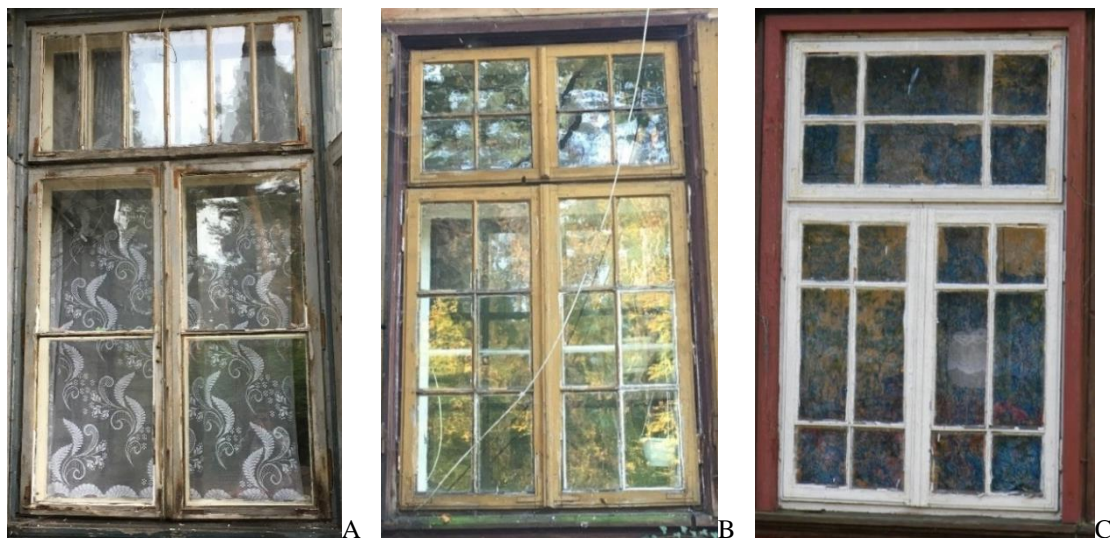
Figure 4. Windows with mullions above and below the transom A- Willowa 6 (No.77), B- Świerkowa 16 (No.73), C- Mała 5 (No.37)

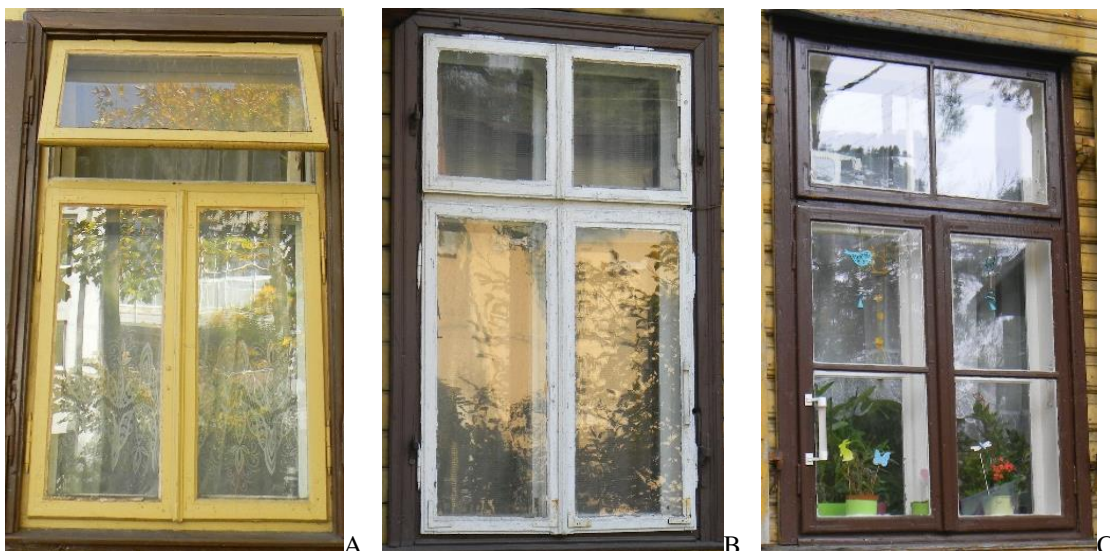
Figure 5. Opens with pivoting upper part: A- Samorządowa 8 (No.66), B- Bagatela 27 (No.3), C- Mickiewicza 25 (No.41)

Out of the 97 windows that have been examined, 56 of them had an awning upper part with hinges mounted on the upper edge of the window. It's an important characteristic of Świdermajers' architecture, because traditionally, at the turn of the 20th century, in Poland, the upper part of the window was almost always a hopper [Tajchman, 1990] (Fig.5).

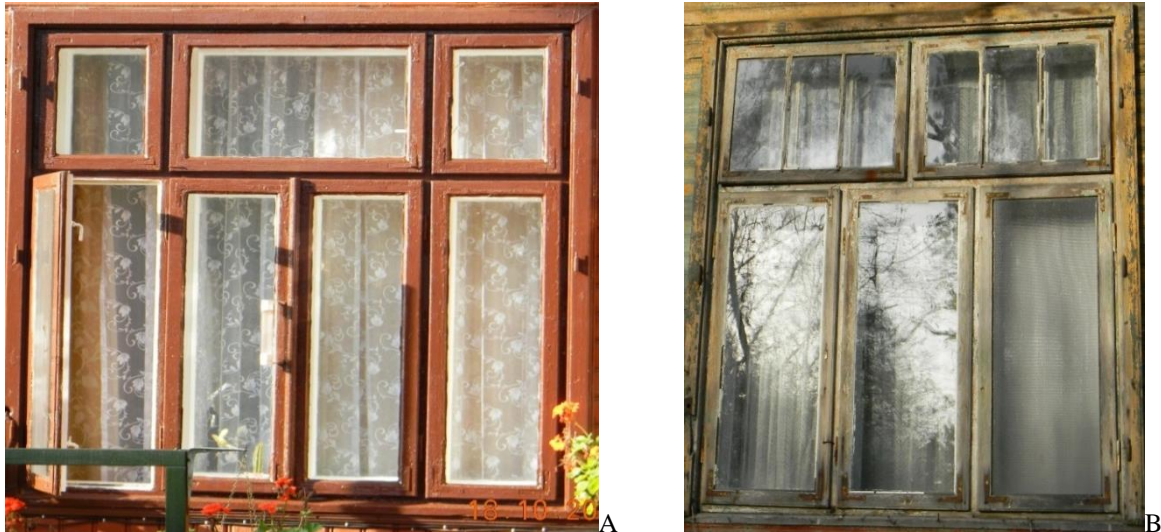
Figure 6. Windows with 7 and 5

There were very few windows with a central stile between casements, replaced in many cases by a lipping batten that covered the space where the two wings meet, which was also characteristic for this period [Tajchman, 1990]. Stiles appeared in wide windows composed of multiple parts. They could be seen in windows divided into two levels: with

three lites in the transom and four lites in the main part below the transom, summing up to a total of up to seven lites in a window (Fig.6A).

In many buildings we documented windows divided into 5 parts, where the upper part, the transom, was made of 2 hopper windows, and the lower part, below the transom, was made of 3 casement windows, with a stile dividing the double-casement window from the single-casement one (Fig.6B).

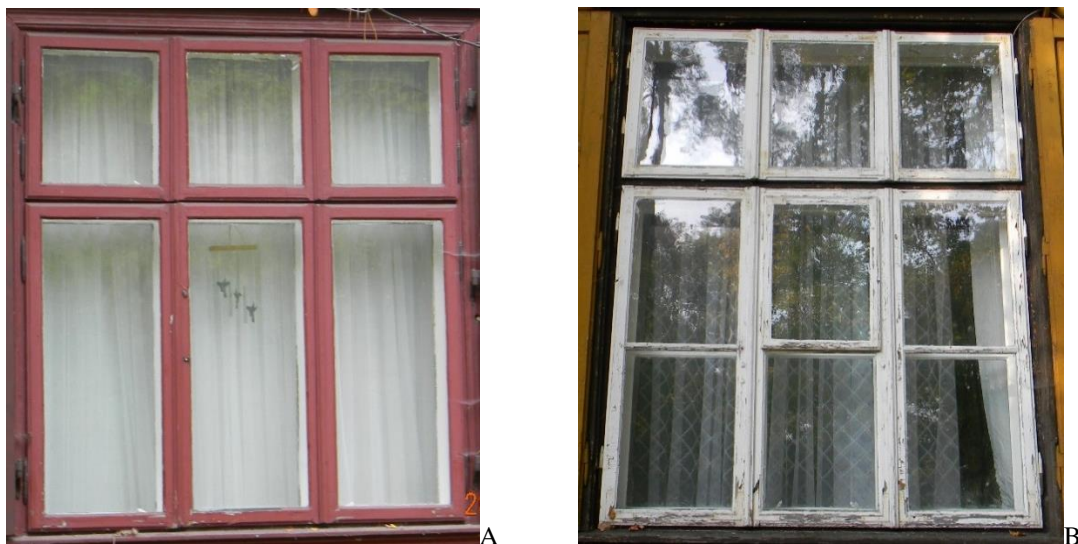
Figure 7. Windows with 6 parts/lites: A- Mickiewicza 31 (No.42), B- Poetycka 21 (No.60)

In some cases, the 6-lite windows had three casements above the transom, which opened on hinges located on the sides, just like the casements in the part below the transom (Fig.7). The height of the part below the transom was sometimes divided into two parts with horizontal muntins, one in each casement (Fig.7B).

("vents") were also included in windows with multiple lites (Fig.7B). In one of the buildings we discovered a window made of two casements, each of them had three levels and each of the separate lites could be opened independently (Table 1, building No. 52, ul.Moniuszki 27).

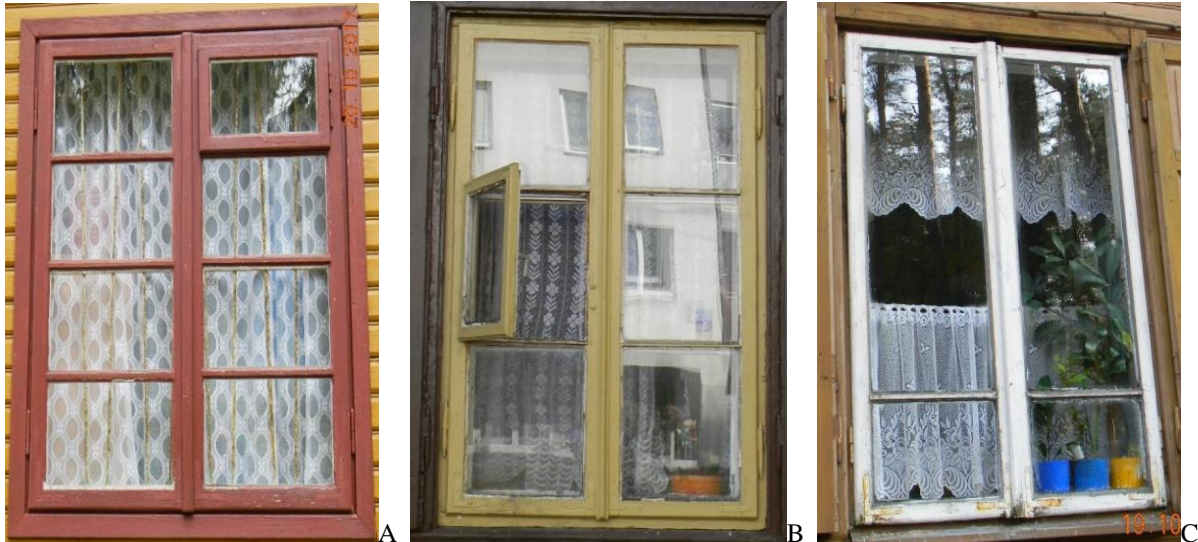
Figure 8. Windows with "vents" (small casement parts opening independently): A- Jana Pawła 13 (No.13), B- Samorządowa 8 (No.66) and a window with mullions placed in its lower part: C- Czarnieckiego 6 (No.6)

Windows from that period often included small parts (“vents”) that could be opened independently to let in fresh air [Tajchman, 1990]. In the buildings under analysis, it is difficult to tell today whether they were authentic or replaced. We know for sure that in 12 double windows, one of the lites of a casement (divided with mullions into usually 3 or 4 lites) was operable (could be opened independently), allowing for room ventilation without the necessity to open the entire casement (Fig.8A and 8B). Such small ventilation openings

Apart from typical windows, whose transom bar was shifted upwards, we also documented 3 windows, whose casements were divided by horizontal mullions in an assymetrical way, where the bottom lite was smaller (Fig. 8C).

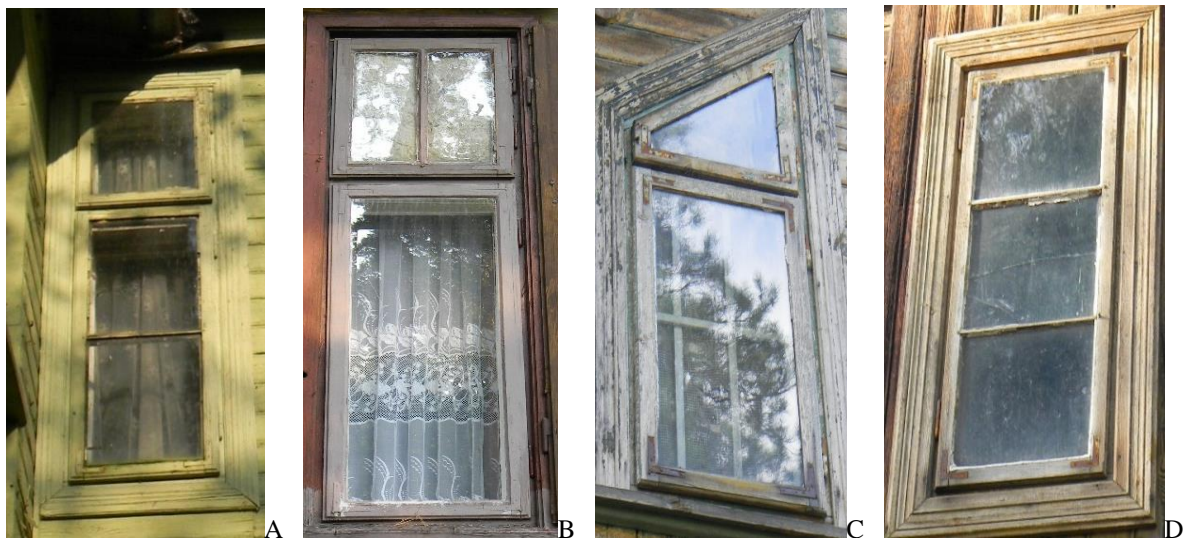
Figure 9. Single-unit windows with transom: A- Mała 3 (No.38), B- Piaskowa (No.57), C- Poniatowskiego 11 (No.63) and a single-unit window: D- Jeremy 5 (No.14).

In 8 Świdermajer buildings in Otwock, there were single-unit windows with various different division patterns of the glass pane. Most of them (a half) had two levels (the main part and the upper transom), and both parts could open by swinging on lateral hinges (Fig.9A, 9B and 9C). Two buildings had single-unit windows divided into three fields with mullions (Fig.9D).

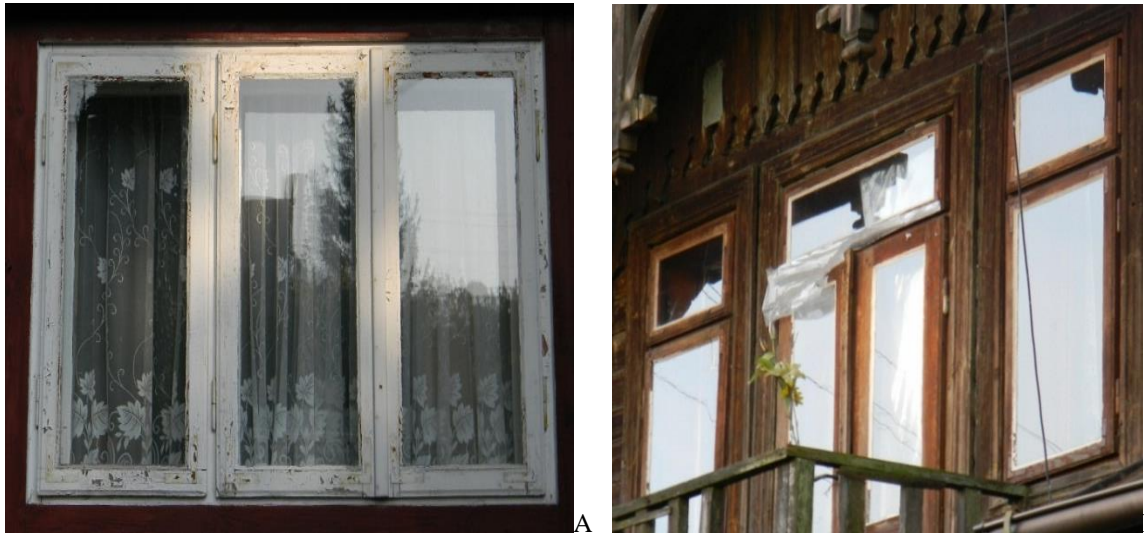
Figure 10. A triple-unit window: single-casement window combined with a double-casement window: A- Poetycka 5 (No.59), and single-unit windows with transom with a more complex central unit: B- Andriollego 66 (No.2)

In many cases, single-unit windows were placed next to one another, forming a row - a wide window composed of three units (Fig.10A) or single-level windows were combined with double-level windows (Fig.10B).

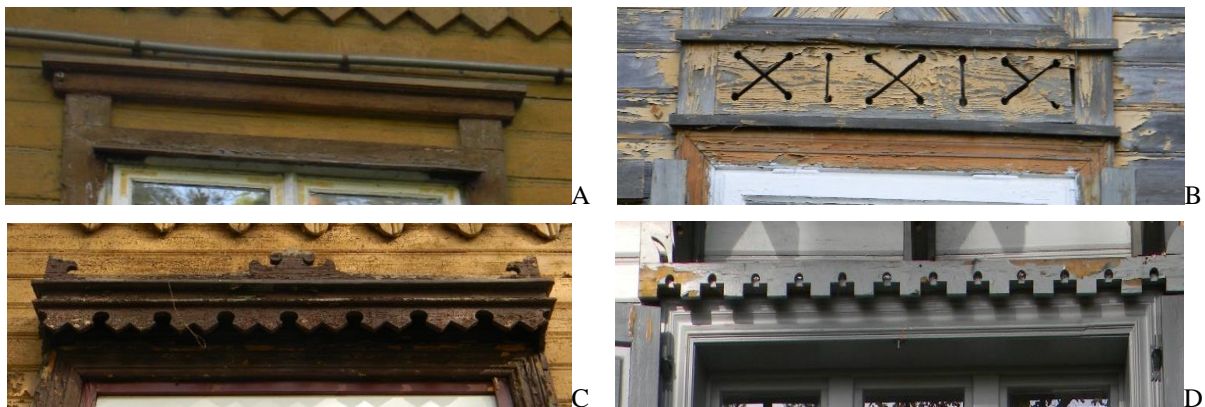
Figure 11. Window cornices: A- Moniuszki 27 (No.52), B- Słoneczna 15 (No.52), C- Samorządowa 16/20 (No.68), D- Lelewela 7 (No.33)

In 54 out of the 80 buildings under research, there were no **decorative cornices** above the windows. This were found only in 26 buildings. In most of them (9 of the buildings under research) they had the form of a small roof that was usually made of wood, but we have also found one made of metal. In some cases, below the little roof there was a frieze that could have simple ornaments (Fig.11A and 11B). In 5 cases, the cornice was made of a batten with a decorative motif of teeth, resembling antique patterns (Fig.11D) or a shape of dovetail (Fig.11C).

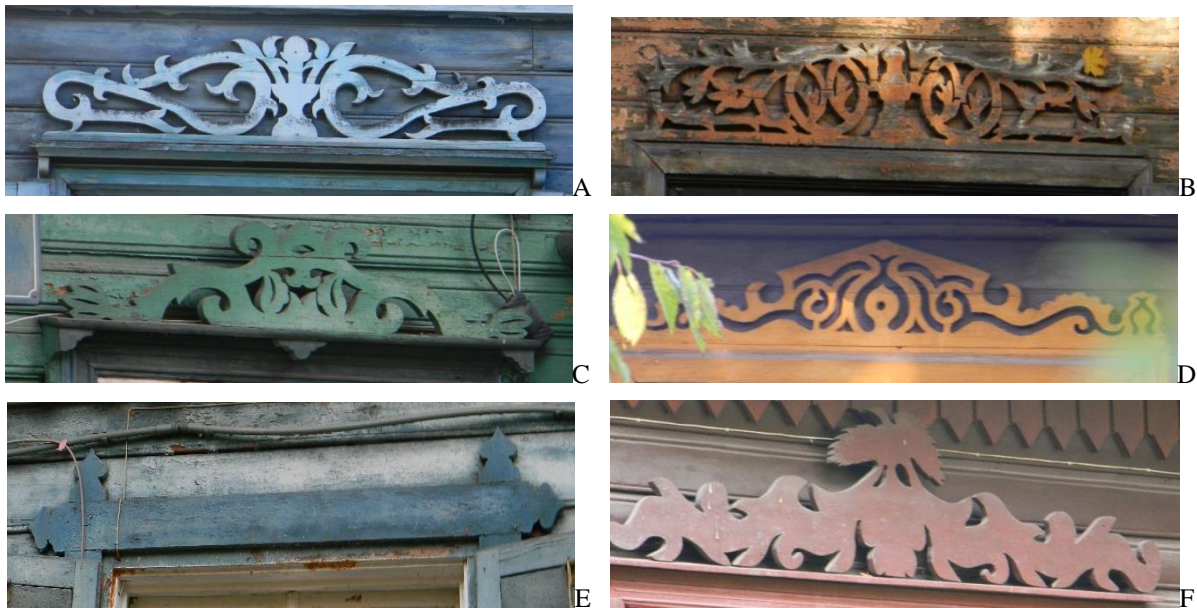
Figure 12. Window cornices with floral motifs: A- Kościelna 18 (No.20), B- Kościuszki 7 (No.24), C- Mickiewicza 35 (No.44), D- Kościuszki 39 (No.30), E- Andriollego 35 (No.1), F- Mickiewicza 31 (No.42)

Equally popular (found also in 5 cases) were window cornices with floral fretwork motifs used in entire Poland and Europe, inspired by the Liebold's pattern handbook, either approached with botanical precision, or simplified, as it was the case in 3 buildings (Fig.12).

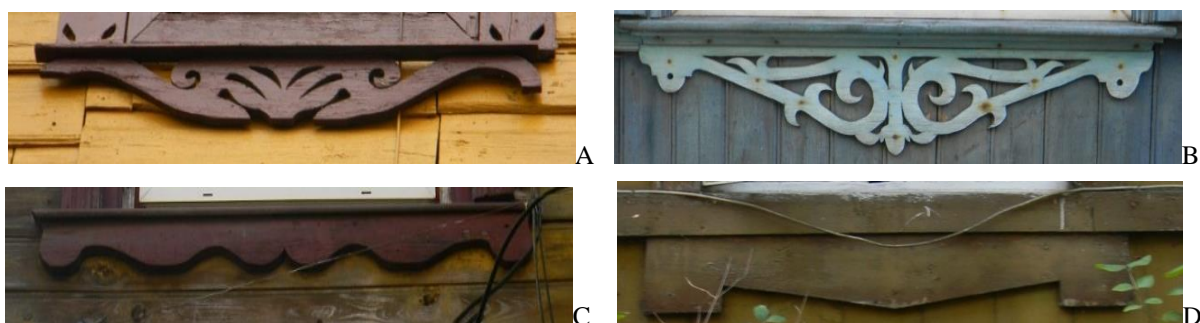
Figure 13. Bands under the windows: A- Kraszewskiego 101 (No.31), B- Kościelna 18 (PL.20), C- Żeromskiego 60/62a (No.80), D- Moniuszki 27 (No.52)

In rare cases, Świdermajers' buildings in Otwock had also a **decorative band below the window**. Out of the 80 buildings included in the research, only 19 had such decorative strips under the windows, and 61 did not. Most of those decorations (in 11 buildings) had the form of a simple, profiled batten placed below the window. In 3 buildings, the battens had a concave-convex line on the lower part of the batten (Fig.13C). In 3 buildings, we could see richly decorated fretwork ornaments, typical of Liebold's handbook: abstract and ornamental, symmetrical patterns (Fig.13A and Fig.13B). In one building there was a typical floral motif with climbing vines (Tab.1, building 20, ul. Kościelna 18). Similarly, in one case we observed a band in the form of a reversed tympanum (Fig.13D).

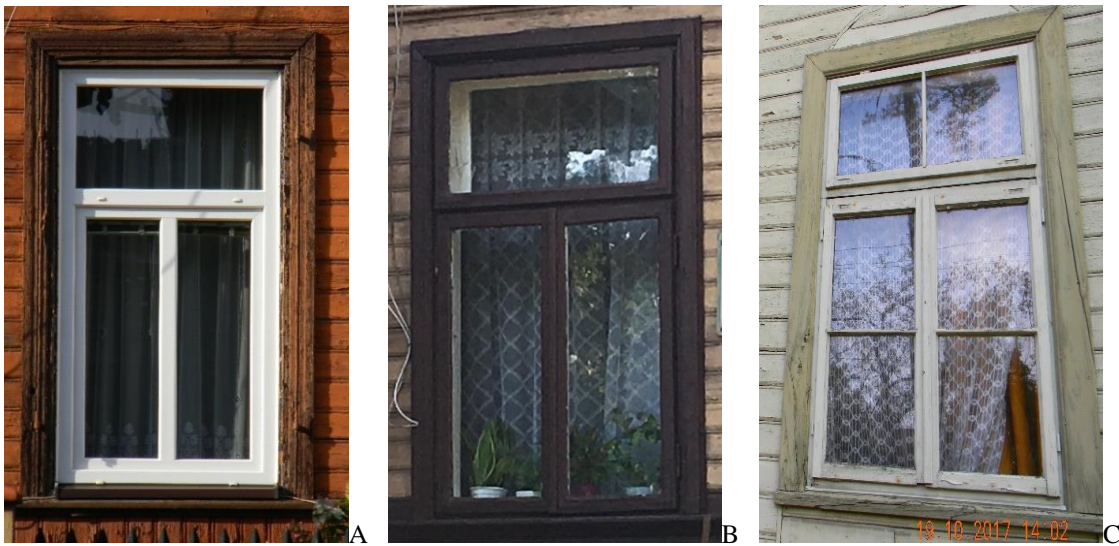
Figure 14. Batten frames around windows: A- Kościelna 23 (No.22), B- Narutowicza 51 (No.55), C- (38) Mała 3 (No.38)

A decorative element that appeared in every building under research were **window frames made of battens**. Most frequently, they were painted the same colour as the window frame, sometimes a slightly darker than the window and the wall boarding, in order to highlight the window visually and make it stand out in a large, uniform and often monotonous wall covered with boarding. The frames were made of wooden battens connected with miter joints in the corners, resembling a painting frame (Fig.14). The battens could be profiled or

not. The profiles were simple, and combined convex and concave elements, sometimes with larger, sudden cuts, to add some diversity.

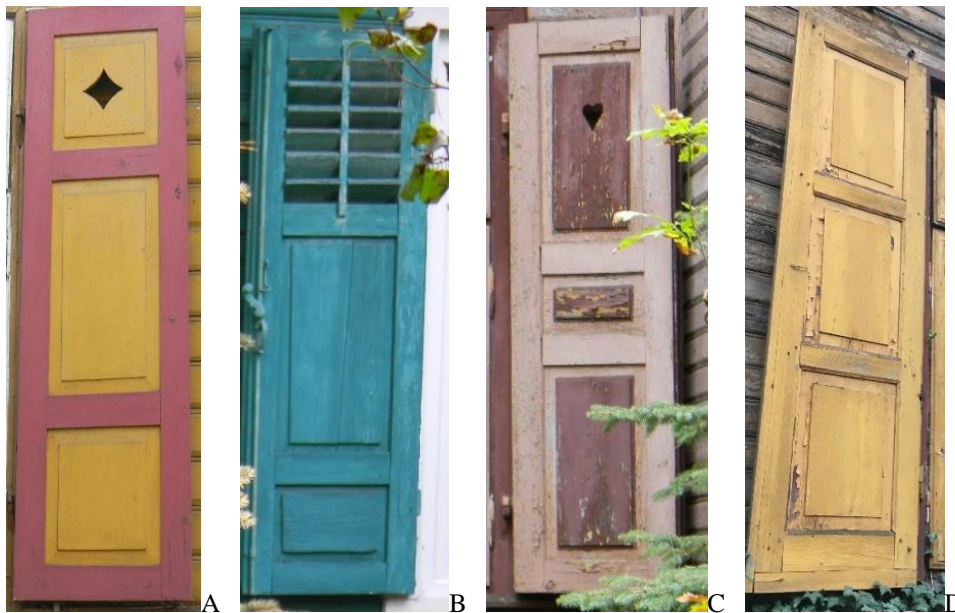
Figure 15. Triple recess shutters: A- Kołataja 29 (No.16), B- Sucha 7 (No.72), C- Majowa 24 (No.36), D- Świerkowa 16 (No.73).

Shutters composed of 3 recess fields had different kinds of divisions (different field proportions). In as much as 30 buildings, the topmost and downmost fields were oriented horizontally (in 25 cases they had the shape of a square and in the remaining 5 cases, a rectangle), and the third, central field was vertically oriented (Fig.15A and 15B).

Sometimes, as an additional decorative element, openings with various shapes were cut in the upper recess, eg. hearts, romboids, triangles or circles (Tab.1, building No.6 ul. Czarnieckiego 6, building No.11 ul. Gliniecka 11, building No.16 ul. Kołłątaja 29, building No.67 ul. Samorządowa 22a). In two cases, the upper recess was replaced with a jalousie doors (Tab.1 building No.72 ul. Sucha 7, building No.15 ul. Jeremy 7- Fig.15B).

This triple shutter division could also have other layouts, with the central recess oriented horizontally and two vertically oriented ones on both ends. Such a solution was discovered in 3 cases: in two of them the central recess was rectangular, and in one square-shaped (Fig.15C).

Moreover, shutters could be divided into three even squares (tab. 1 building No. 73 Świerkowa 16 – Fig.15D), or with field dimensions becoming smaller towards the bottom (tab. 1 building no. 77, ul. Willowa 69).

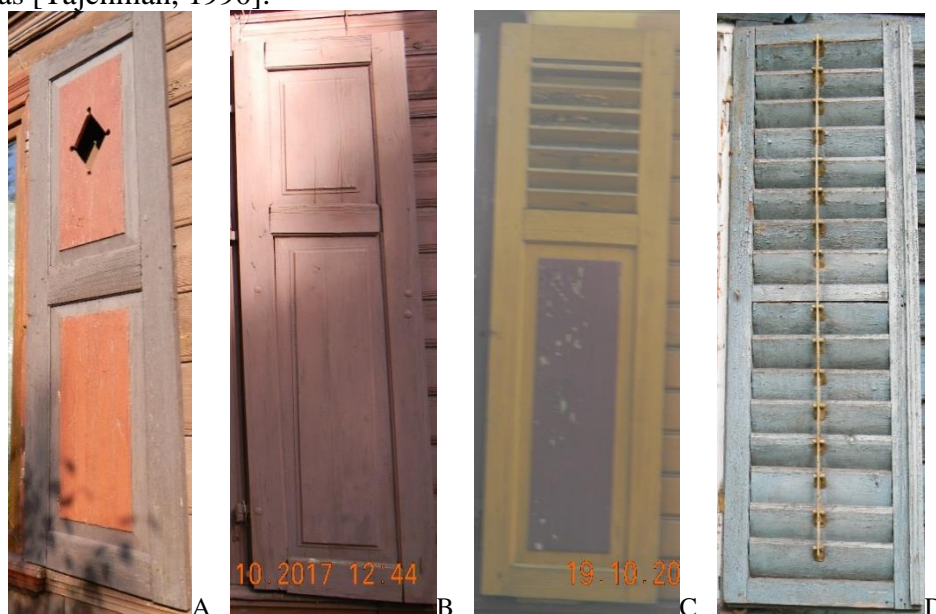
Figure 16. Double-field shutters: A- Kościuszki 19 (No.26), B- Reymonta 29 (No.65), C- Krótka 10 (No.32), D- Andriollego 35 (No.1)

The division of shutters into two recesses was observed in 12 buildings, as it has been mentioned above. Nine of them had even, vertical rectangles (Fig.16A). Only in 2 buildings the shutters had a square recess in the upper part and a vertically oriented, elongated rectangle below (Tab.1, building No.32, ul. Krótka 10, building No.65, ul. Reymonta 29). One of those shutters had a jalousie in the uppermost recess (Fig. 16C).

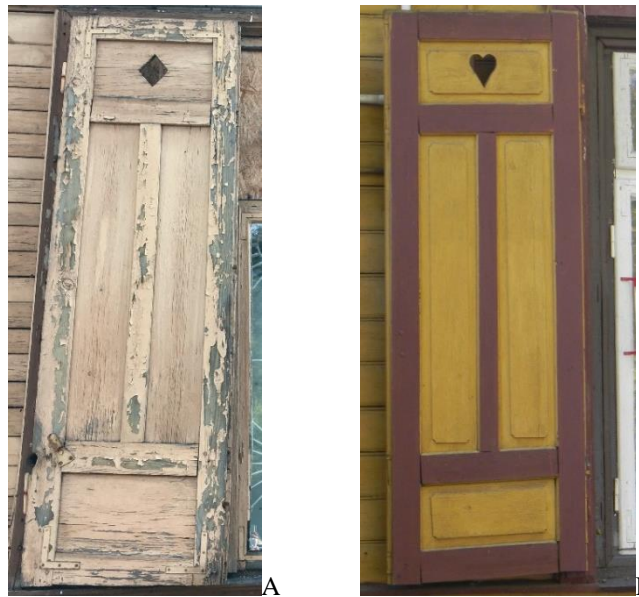
Figure 17. Shutters with four fields: A- Narutowicza 53 (No.56), B- Moniuszki 20 (No.50)

As it has been mentioned before, only 2 houses had shutters with 4 fields, with the uppermost and downmost fields oriented horizontally, and the middle ones vertically (Fig.17).

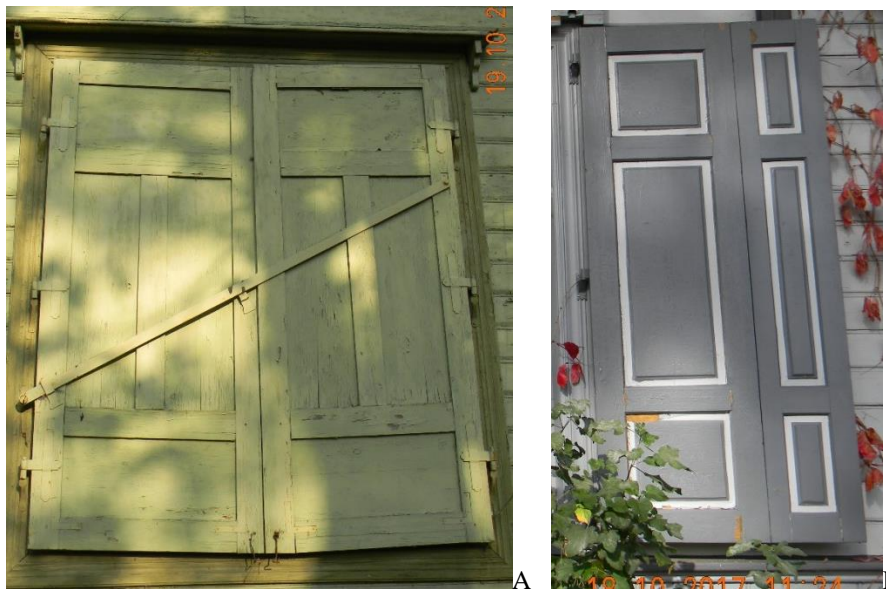
Figure 18. Shutters with single, wide shutters on each side: A- Mała 3 (No.38), and shutters divided into with two asymmetrical casements on each side, connected with hinges: B- Lelewela 7 (No.33).

Out of these 9 buildings, 5 had shutters made of single units on each side, or in other words, each of the shutters was separate (Fig.18A), but in this case they were wider by ca. 30% (Tab.1 building No.57 ul. Piaskowa, building No.6 ul. Czarnieckiego 6, building No.38 ul. Mała 3). In 3 buildings, there was an additional casement added on each side, meaning that each shutter unit was made of a main shutter with an additional, narrower (also about 1/3 of the width) casement fixed to the main shutter (Tab.1, building No.33 ul. Lelewela 7, and

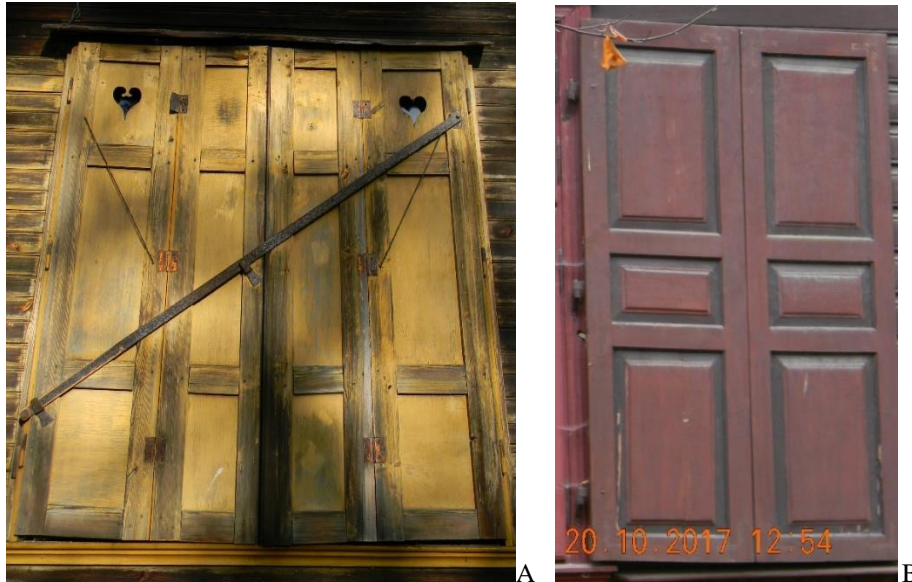
Figure 19. Shutters made of two casements each, connected with hinges: A- casements of similar width, Jaremy 5 (No.14) and B- of identical width, Mickiewicza 35 (No.44)

building No.60 ul. Poetycka 21). In one case, we observed shutters made of double-casement shutters on each side, so each shutter was made of two casements of similar width, connected to each other with hinges (Tab.1 building No.14 ul. Jaremy 5- Fig.19A). The building no. 44 at Mickiewicza 35 was an exception. It had double-casement shutters on each side, made of two casements of equal width, connected with hinges (Fig.19B).

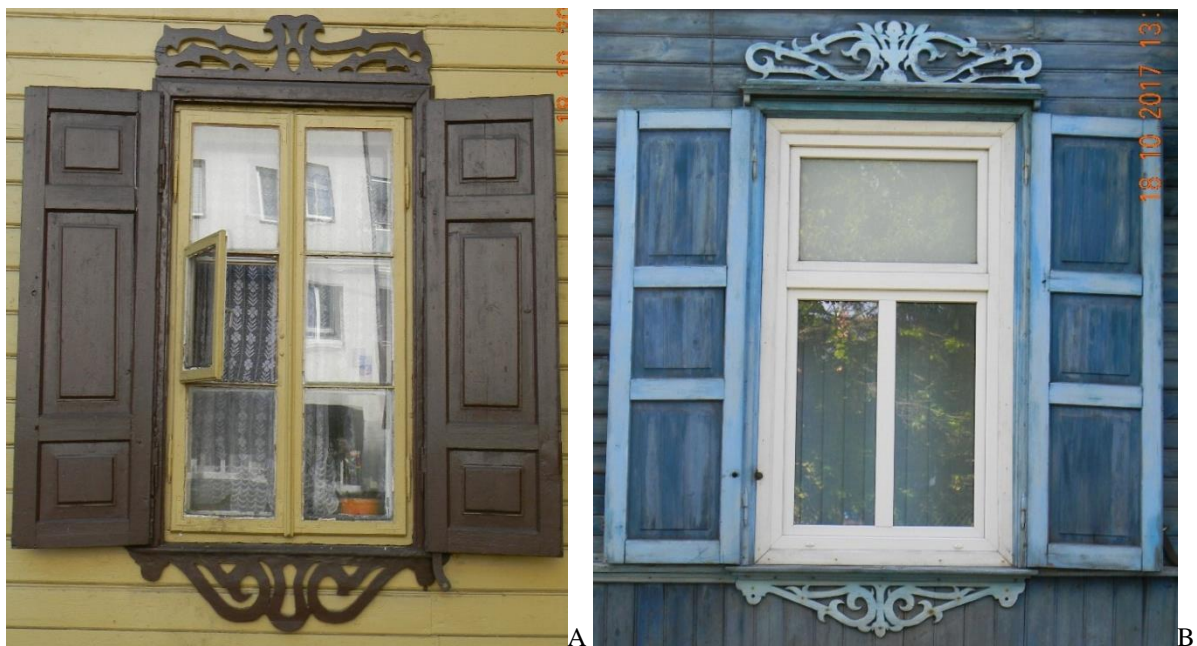
Figure 20. Windows with all the decorative elements: A- Samorządowa 8 (No.66), B- Kościelna 18 (No.20)

There were very few windows that would include all of the decorative elements: cornices above windows, decorative bands below windows, batten framing and shutters (Table 1, building No. 66 ul. Samorządowa 8, building No. 18 ul. Konopnickiej 7 and building No.20 ul. Kościelna 18; see also Fig.20)

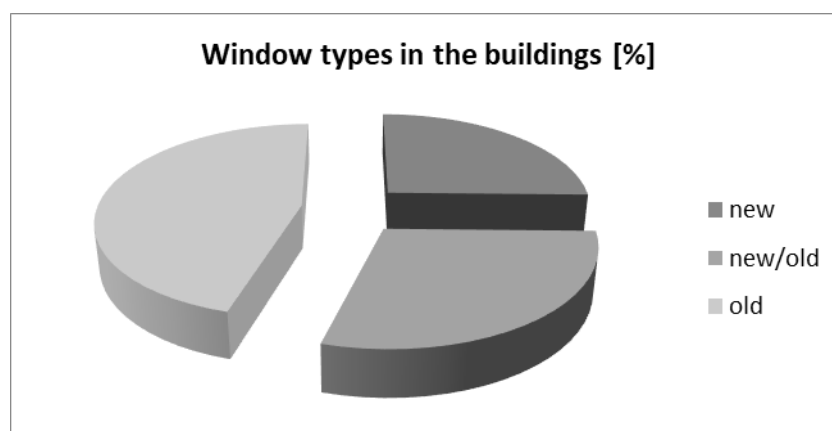
Chart 2. Number and type of windows in the buildings under research, together with a table with percentual share of the results

Most (46%) buildings had original windows with typical structure for Polish windows (frame with two swinging casements and lateral hinges). Additionally, this kind also appeared in buildings where at least one family replaced their set of windows with new, plastic PCV windows (29% of the buildings). Nonetheless, an important number of buildings - as much as 26% of the buildings under research - had only modern windows. It is expected that due to the poor state of preservation, the percentage of replaced windows will grow in the upcoming years. Chart 2 presents a summary of the amount and types of windows in the wooden Świdermajers' buildings under research.

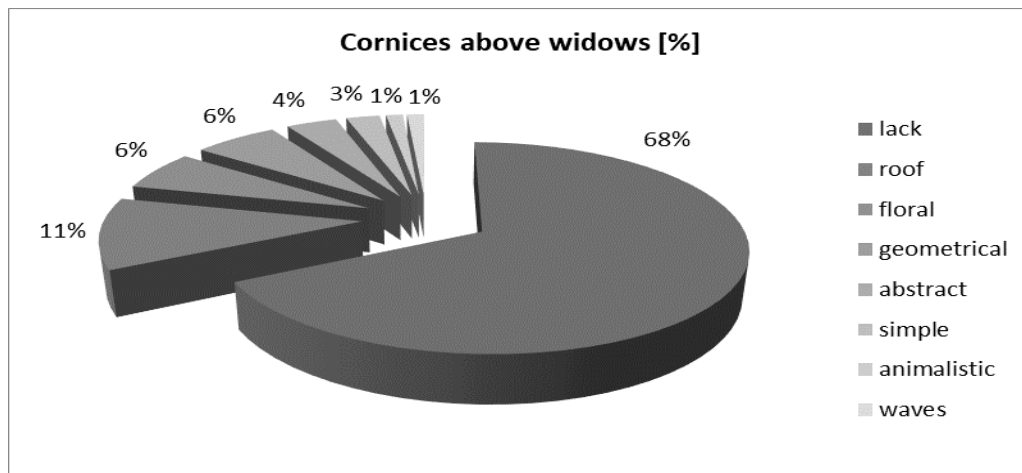
Chart 3. Number and types of decorative motifs above windows

The number and type of ornamental motifs used in the cornices above windows has been presented in Chart 3.

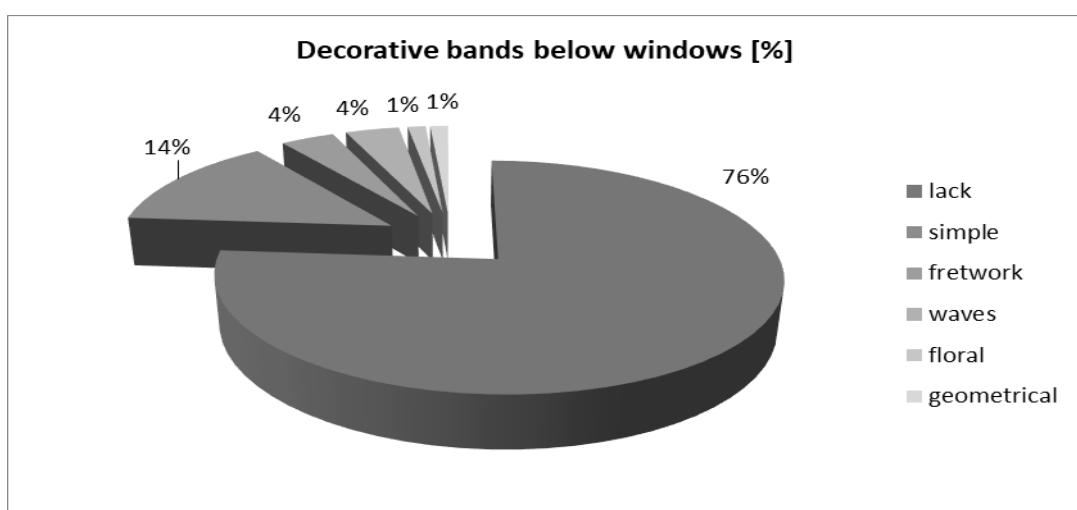
Chart 4. Number and types of decorative motifs below windows

Decorative bands below the windows were present in 24% of the buildings. This is almost by 10% less than in the case of cornices. This is due to the fact that this ornamental element was not very popular. It may be so also due to the period when the buildings were erected, when ornaments were less elaborate in general. The most frequent kind of decoration placed below the window was a profiled batten. The number and types of decorative bands below the windows has been presented in Chart 4:

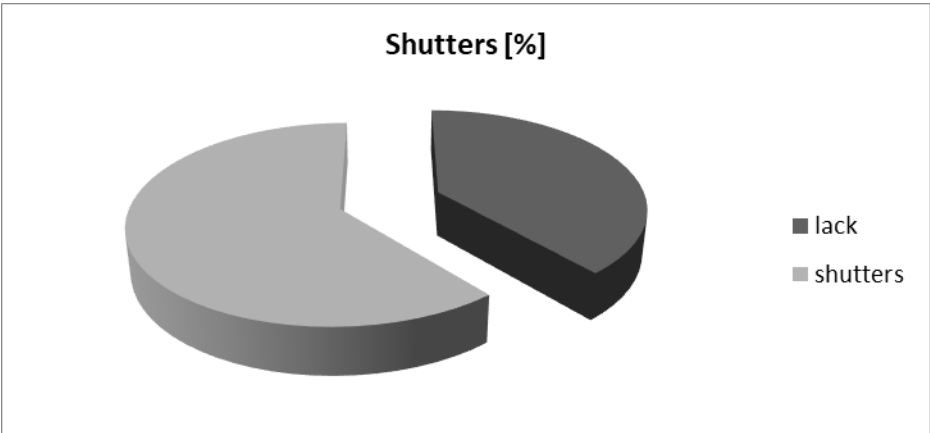
Chart 5. Presence or lack of shutters in the buildings under research

and recess. Quite often they had various different colours, with diverse dimensions and divisions, but triple-recess shutters were the most frequent. A summary of shutter presence in houses is shown in Chart 5 and 6.

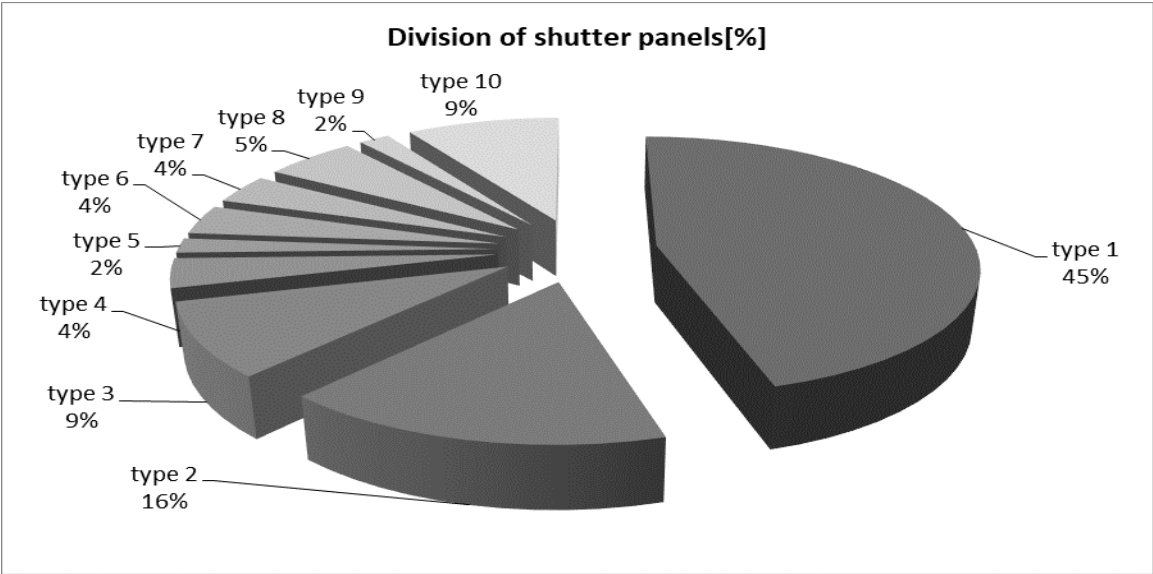
Chart 6. Types of division of shutter panels:

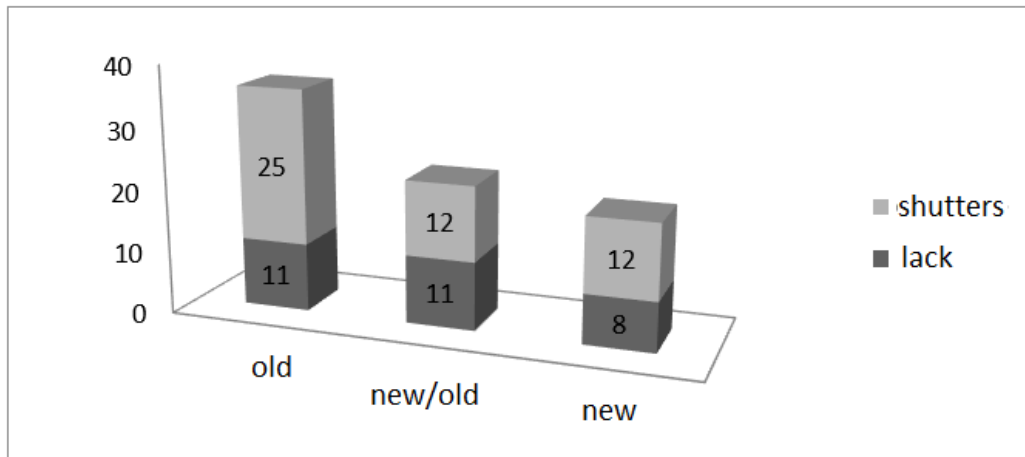
Chart 7. Presence and absence of shutters in original and replaced windows

The presence and absence of shutters in original and replaced windows has been indicated in Chart 7. We can see that even in cases where all the windows in a building were

replaced with new ones, in most of them (60%) the original shutters were left intact. In 31% of the buildings that still have antique window carpentry, there are no shutters (they have been preserved in 69% of the buildings). In buildings where the original windows have been only partially preserved, roughly a half of them still have the original shutters (they have been preserved in 52% of the buildings).

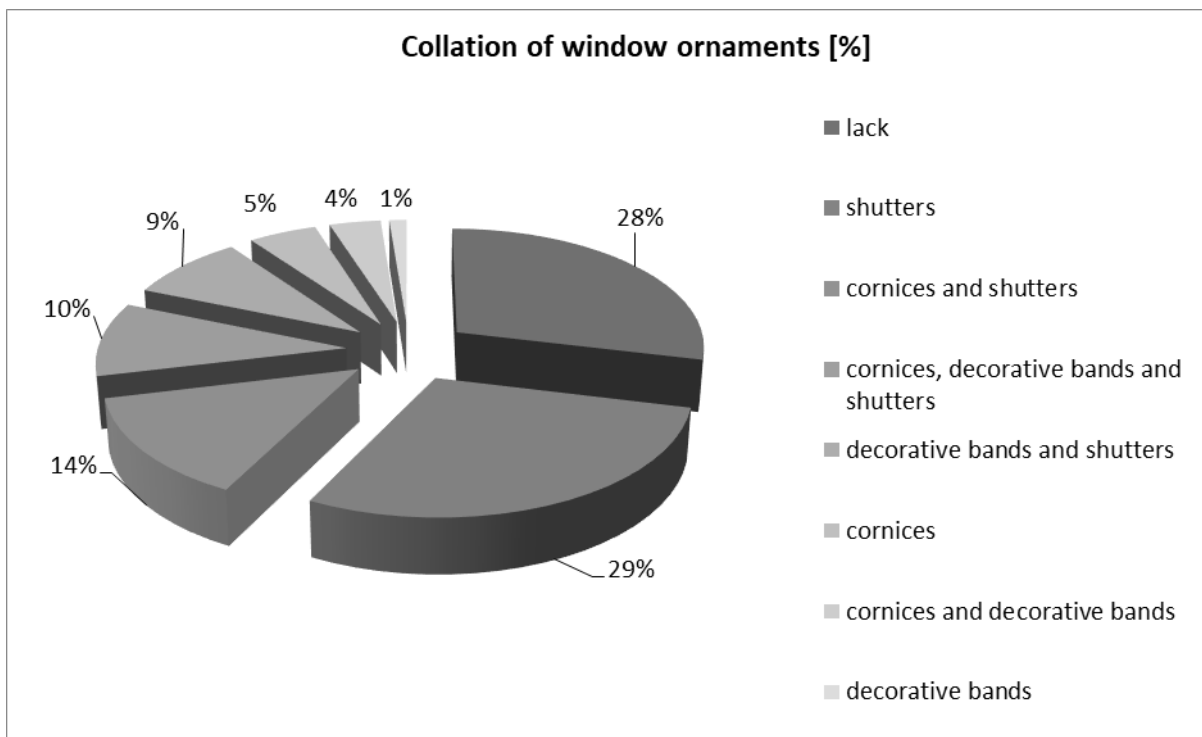
Chart 8. Percentual share of each kind of window ornaments. The chart does not include the batten framing, whose presence was observed in 100% of the cases - in all 80 buildings under research.

shutters as an ornament (23 houses in each case). This proves that the windows were not richly ornamented or the original ornaments did not survive until today. A quantitative comparison of different kinds of window ornaments shows that shutters are the most frequent. In 11 cases, buildings were ornamented with both shutters and cornices above the windows. Windows with a full range of decorations were observed in only 8 of the buildings. The second largest set of decorations were buildings that had both shutters and decorative bands below the windows. Four buildings had only cornices as decoration. Three houses had decorations both underneath and above the windows. There was one building whose only ornament was the band below the window. Chart 8 presents the percentual share of each kind of decorative element.
