Analysis of the causes and effects of landslides in the Carpathian flysch in the area of Milówka and evaluation of their prevention methods

MAŁGORZATA JASTRZĘBSKA, MARIAN ŁUPIEŻOWIEC

Faculty of Civil Engineering, Silesian University of Technology, Gliwice, Poland

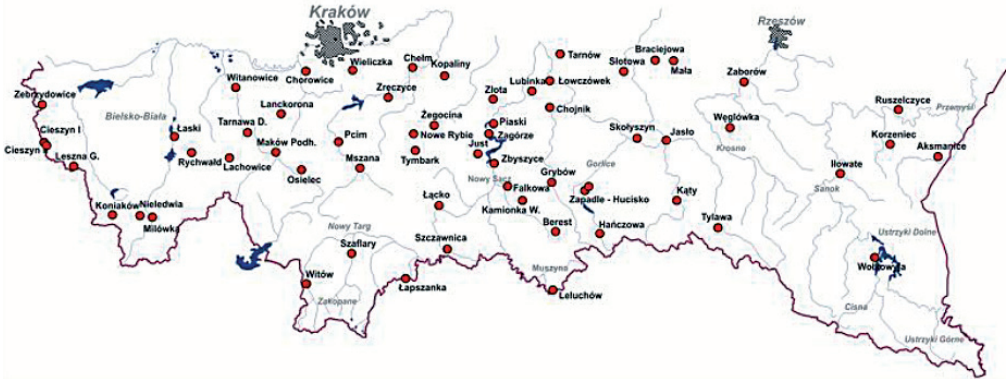
FIGURE 1. A map of landslides with SOPO monitoring (www.pgi.gov.pl)

At that time, they were estimated at 8,500, and 2,970 of which posed a threat to residential buildings. Since then, landslide phenomena have intensified to the alarming level (www.pgi.gov.pl). In 2010 a special landslides counteracting program was introduced called *system osłony przeciwosuwiskowej* (abbreviation SOPO). The primary objective of SOPO is an ongoing monitoring of threatened areas (Fig. 1). The basis of activities is an underground observation (piezometers, inclinometers) and overground (GNSS satellite scan, laser scanning, interferometric synthetic aperture radar – InSAR, rain gauges).

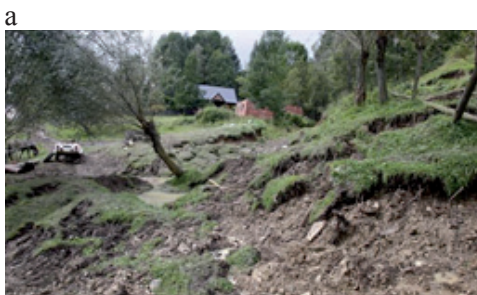
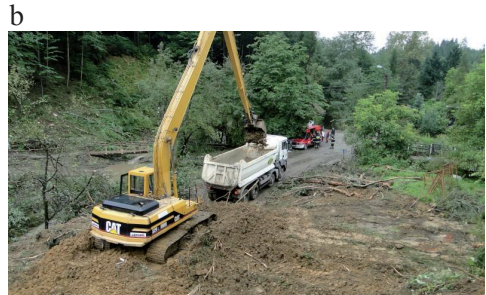
FIGURE 2. General view of the damage on the Milówka Siedloki landslide in September 2010 (www.onet.pl): a – a part of a landslide; b – destroyed regional road

still subject to massive movements on its entire surface, resulting in the destruction of the county road and tightening the Salomonka riverbed (Fig. 2). In the upper part of the landslide, surface displacements

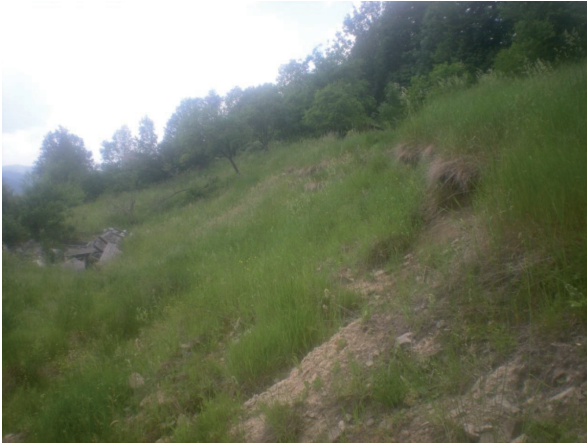
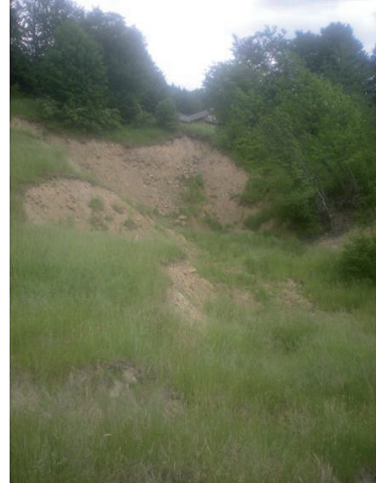
FIGURE 3. General view of horizontal displacements on the Milówka Siedloki landslide in June 2015 (Dziedzic and Golan 2016): a – upper edge of a landslide; b – main landslide threshold

amounted to over 6 m (Fig. 3). Within the colluvium of the landslide there were numerous secondary niches, crevices and cracks (Fig. 4) filled with water during rainy periods. The strong hydration of the

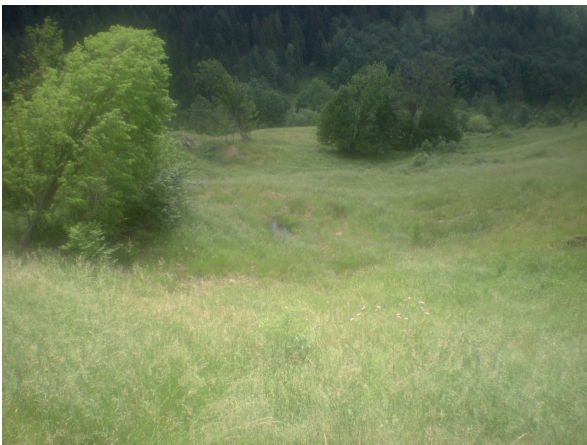
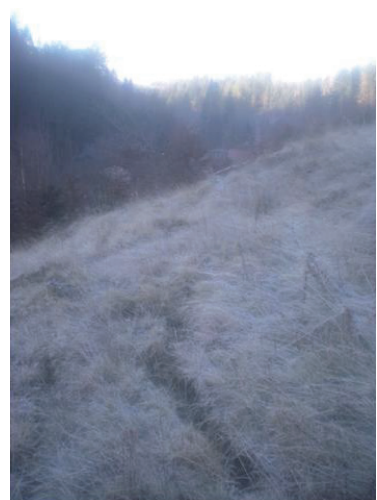
FIGURE 4. General view of the colluvium of the landslide in Milówka Siedloki (Dziedzic and Golan 2016): a – “a drunk forest”, niche filled with water; b – visible cracks – winter 2014/2015

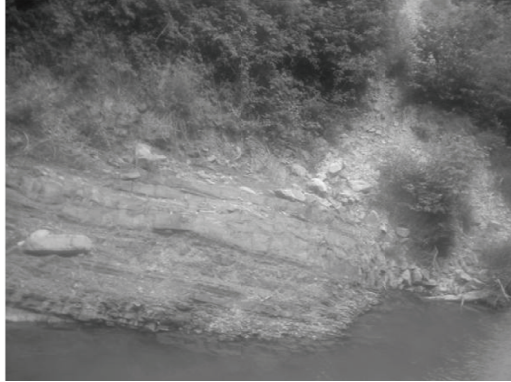
FIGURE 6. The argillaceous schist outcrop in the bottom of the stream (Dziedzic and Golan 2016)

On the basis of seismic profiling along the slope (Documentation 2011a), three layers with different parameters were separated. The highest layer with the smallest thickness has been classified as clay and debris with a maximum thickness of about 5 m. The middle layer was classified as a strongly cracked and damaged rock mass, with a thickness ranging from 8 m to about 30 m. The depth of this layer represents the potential slip surface. The third, lowest and intact layer is a solid rock substrate made of sandstone interlaced with argillaceous schist, which is very well visible in the stream bed, as shown in Figure 6.

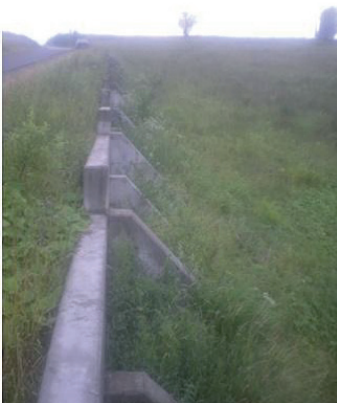
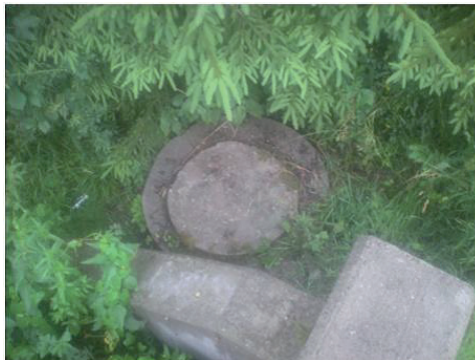
FIGURE 7. Retaining wall on the landslide Milówka Nielewida (Dziedzic and Golan 2016): a – upper retaining wall; b – middle retaining wall with an absorption well

The design office "Zamek" from Kraków designed three retaining walls in the lower, middle and upper part of the village in order to stabilize the regional

road S 1437. These were retaining ribbed walls with different heights and lengths of dilated segments. The main wall and ribs were 0.3 m thick. The Gonar rod system with metal heads concreted into a bench of retaining wall and a drainage system for areas located above the road was suggested as an additional security. In the constructed reinforced concrete box, it was possible to re-grow vegetation due to filling it with native soil (the item was included in the analysis of the stability of the system). Therefore, it was a combination of an engineering and biotechnical solutions that blended in with the surroundings very well (Fig. 7). Linear drainage was done behind the central retaining wall on the road side parallel to the axis of the wall, i.e. parallel to the upper edge of the formed landslide, and the rainwater was drained to the absorption wells (Fig. 7b).

Observations from July 2015 confirmed the effectiveness of the applied solutions, especially in the case of the central retaining wall, in which the minimum dilatation and displacement of the

dilatation appeared, contrary to the other walls with significant displacements. In addition, no longitudinal cracks in the asphalt were observed, which indicates the stabilization of the displacement and the inhibition of the landslide.

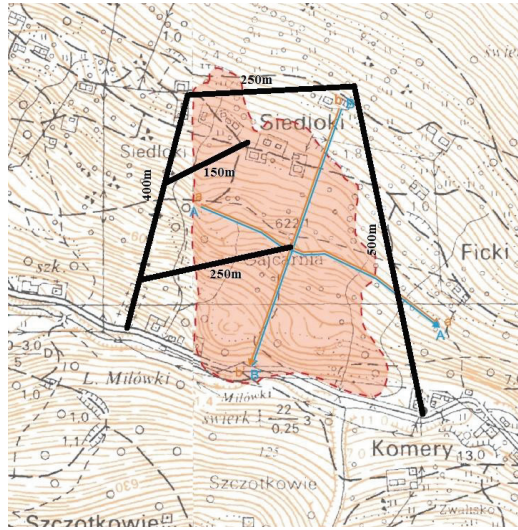
FIGURE 8. Proposed scheme for linear landslide drainage in Milówka Siedloki (Dziedzic and Golan 2016)

The risk of mass movements is still real on this location, which is confirmed by the numerical stability analyses. Securing the landslide against further escalation in a large area is practically impossible due to the potential costs. After the analysis of the causes, it was found that future stabilization works should maximally drain this area and reduce the amount of water infiltrating the colluvium. Finally, the surrounding drainage was suggested for the landslide crown (about 1,500 m), which cuts off the inflow of water from the top of the slope to the colluvium and discharges the rainwater to the nearby Salomonka stream (Fig. 8). Additionally, it was recommended that the colluvium areas should be filled with plants that

have good transpiration properties (e.g. alfalfa, rye, oats, larch, beech). It would be possible to resign from the latter, provided that regular grass trimming will be planned and conducted, which was neglected after 1989. There are many indications that the abandonment of agricultural fields, that absorb huge amounts of water from the soil, is one of the important factors affecting landslide activity (especially in Milówka).

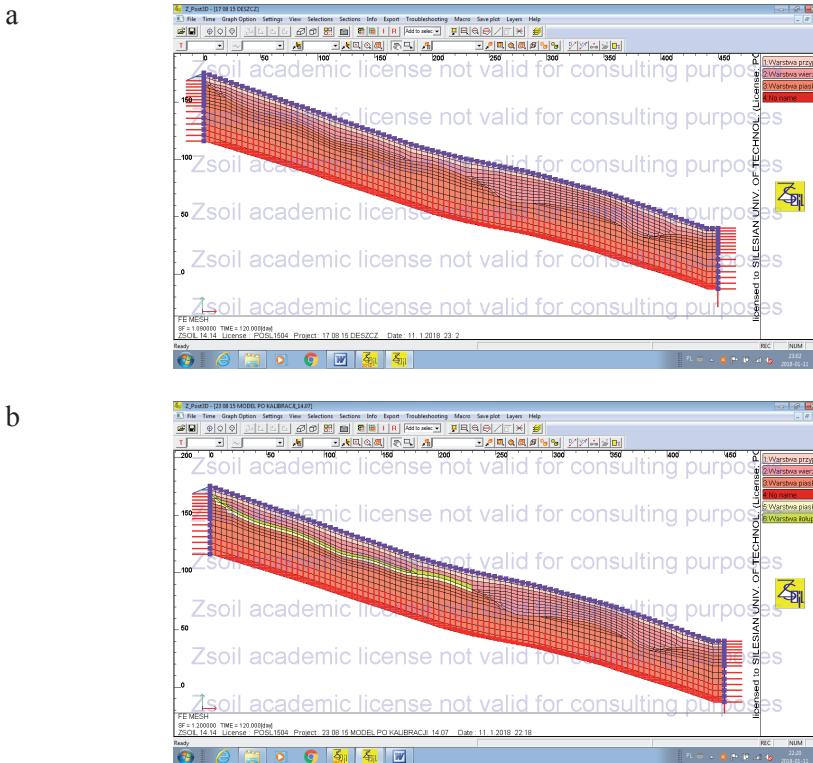
FIGURE 9. Numerical model in stability analysis: a – on the basis of soil exploration; b – on the basis of calibration including degradation of material (Dziedzic and Golan 2016)

The numerical model used in the calculations is shown in Figure 9a. The model limits the shape of the slope, which was mapped on the basis of geodetic meas-

urements (Documentation 2010a, b). Most often, the model's floor is horizontal, which facilitates the task of boundary conditions. However, it is also allowed take a bottom that is parallel to the slope, which reduces the number of finite elements and causes a more favorable shape of these elements, which results in shortening the calculation time and improving convergence. In the present case, the second method of the model geometry selecting was used. In numerical analyses, the finite element method was used, and the stability was analysed using the previously described $c-\phi$ reduction procedure. The soil should be analysed as a two-component medium consist-
