Przegląd Naukowy – Inżynieria i Kształtowanie Środowiska nr 56, 2012: 50–57
(Prz. Nauk. Inż. Kszt. Środ. 56, 2012)
Scientific Review – Engineering and Environmental Sciences No 56, 2012: 50–57
(Sci. Rev. Eng. Env. Sci. 56, 2012)

Mirosława GÓRECKA

Application of architectural solutions in thermal modernization of existing buildings on rural areas
Zastosowanie rozwiązań architektonicznych przy termomodernizacji istniejącej zabudowy na terenach wiejskich

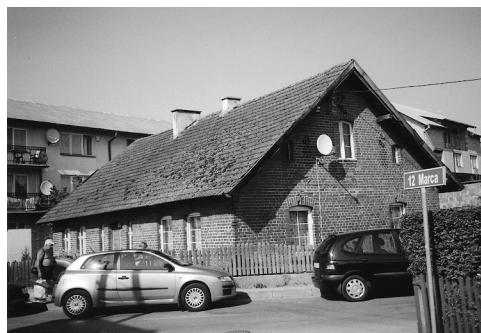
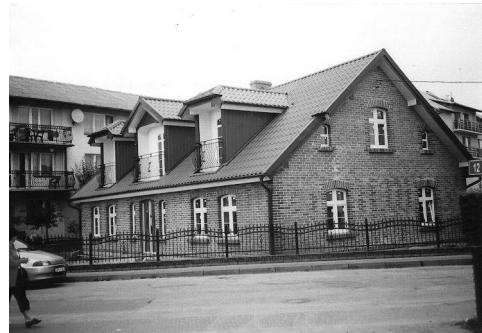
FIGURE 1. Modernization with thermal modernization of building made of red brick from the turn of 19th and 20th centuries. Some reservations can be expressed about the mansards of various covering forms, faced from inside with a white siding, as well as replacing the traditional ceramic roof tile with a metal one: a – state before modernization, b – state after modernization – Karwia, June 2005 – August 2008 (photo by Author)

RYSUNEK 1. Modernizacja z termomodernizacją budynku z czerwonej cegły z przełomu XIX i XX wieku. Zastrzeżenie budzą mansardy o różnych formach przekrycia oblicowane od wewnętrz białym sidingiem oraz zastąpienie tradycyjnej dachówkki ceramicznej blachodachówką: a – stan przed modernizacją, b – stan po modernizacji – Karwia, lipiec 2005 – sierpień 2008 (fot. autor)

As a rare – unfortunately – example of the thermal modernization having essential meaning for a country building from the point of view of its architecture, there can be observed the cover with a traditional steep roof (with an attic playing a role of a thermal buffer) and protection of the enter zone against external atmospheric conditions (Figure 3). There must be emphasized that due to constructive and architectural accounts, the extension of so-called "cube-houses" from the 1960's and 1970's is difficult. If the problem is being solved within the existing storeys, it is connected to the

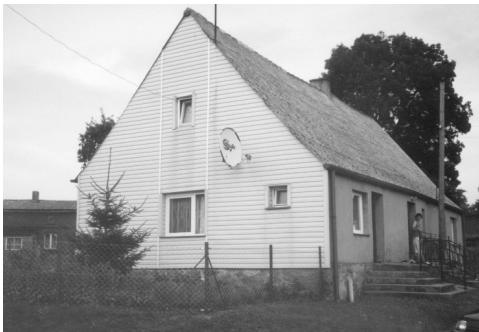
FIGURE 2. Clay dwelling house from the end of 19th century. Only the western wall of the building is protected against wind and rain and only with siding, without insulation. Also the wooden windows had been changed to the new, plastic – Minkowice, July 2002 (photo by Author)

RYSUNEK 2. Dom mieszkalny z gliny, z końca XIX wieku. Jedynie zachodnia strona budynku została zabezpieczona przed wiatrem i deszczem wyłącznie oblicowaniem sidingiem, bez ocieplenia. W domu wymieniono również drewniane okna na nowe plastikowe – Minkowice, lipiec 2002 (fot. autor)

tion of external walls against the unprofitable influence of the climate limits itself only to one of the building's walls and even only to its facing (Figure 2). This occurrence comes from the lack of financial resources of rural investors and is quite characteristic especially for the northern regions of Poland which do not belong to the wealthiest ones.

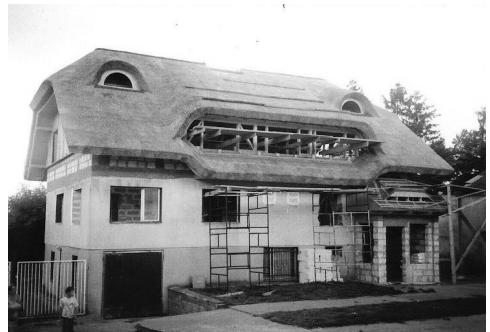
FIGURE 3. Ecological thermal modernization of a building from the end of 1970's consisting in construction of a superstructure and covering the house with a step roof. An attempt of reference to tradition – a thatched gable roof with jerkin head. Some reservations can be expressed about the building enormity, resulting from the high cellar, differing from that historically developed – Minkowice, July 2008 (photo by Autor)

RYSUNEK 3. Ekologiczna termomodernizacja budynku z lat siedemdziesiątych ubiegłego wieku polegająca na nadbudowie i przekryciu domu dachem stromym. Próba nawiązania do tradycji – dach dwuspadowy naczółkowy kryty trzciną. Zastrzeżenie budzi skała budynku, wynikająca z wysokiego podpiwniczenia, odbiegająca od tej wykształconej historycznie – Minkowice, lipiec 2008 (fot. autor)

problem of high ground floor; if the investor decides to a superstructure on the existing object, usually changes this object into a tenement what causes departure from the traditional and historically developed form of country buildings.
