INFLUENCE OF SUBGRADE SOIL ON PAVEMENT PERFORMANCE: A CASE STUDY OF AGO-IWOYE – ILISHAN ROAD, SOUTHWESTERN NIGERIA

Ago-Iwoye –Ilishan road is the major road that links Abeokuta the state capital of Ogun –state to Ijebu towns. The road has always been experiencing pavement failure, which occurs in form of cracks and potholes. Being the major road, the effect of the failure has negative impact on the socio-economic growth of Ijebu –areas. The primary objective of the study was to determine the influence of the geotechnical properties of the sub-grade materials on the pavement performance of Ago-Iwoye – Ilishan Road. Eleven (11) soil samples were collected at eight (8) different locations with the aid of hand auger and were air-dried before taken to the laboratory for determination of engineering properties. The Liquid limit and the Plastic limits ranged from 13.9 – 46.2% and 8.1 – 32.7%, with the Plasticity index from 10.6 – 15.9% and Shrinkage limit from 6.2 – 27.7% respectively. The soaked CBR values of the subgrade materials is between 67% and 75% compared with 30% minimum specified by FMWH, 1997.

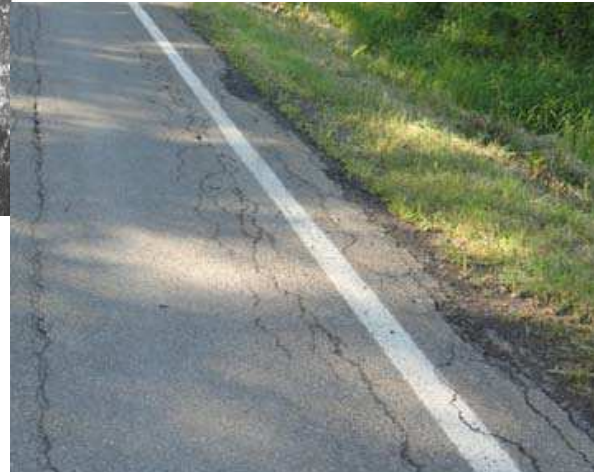
Plate 2: Cracks on the pavement of the study Highway

Ago-Iwoye –Ilishan road is the major road that links Abeokuta the state capital of Ogun –state to Ijebu towns. The road has always been experiencing pavement failure, which occurs in form of cracks and potholes (see Plate 1&2). Being the major road, the effect of the failure has negative impact on the socio-economic growth of Ijebu –areas. The primary objective of the study was to

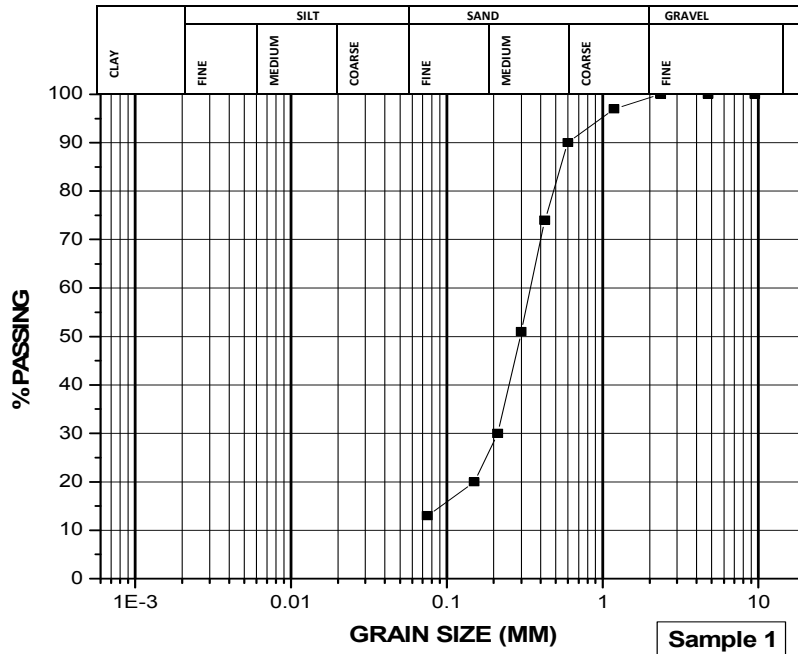
Figure 3a. Grain size distribution curve for Sample 1

Figure 3a shows the grain size distribution curve for sample 1 where the percentage of soil passing is plotted against the grain size (mm). This shows that percentage of coarse soil is 86%, while that of fine soil is 14%. For figure 3b, the percentage of coarse soil is 98% and fine soil is 2%. Table 1 shows the summary of the geotechnical properties of the subgrade soils. The values represent the average for three replicate of each sample tested.

Eleven (11) samples were collected at eight (8) different locations with the aid of hand auger and digging tools for trial pits. The soil samples were air-dried before being subjected to the laboratory tests such as the grain size analysis, moisture content, consistency limits, compaction test and the California Bearing Ratio (CBR). The results of the grain size analysis were presented as grain size distribution curves, that is, plotting of percentage of soil passing against the grain size on a semi-log graph. Typical grain size distribution curves are shown at Fig. 3 (a&b).

The results of the laboratory analysis of the soil samples were presented as distribution curves and summary of geotechnical properties of the subgrade soils. A typical distribution curve is as shown in figure 3.0 (a&b).
