Some aspects of the sediment transport during the 2005 floods in Switzerland

MARTIN JAEGGI

River Engineering and Morphology, Ebmatingen, Switzerland

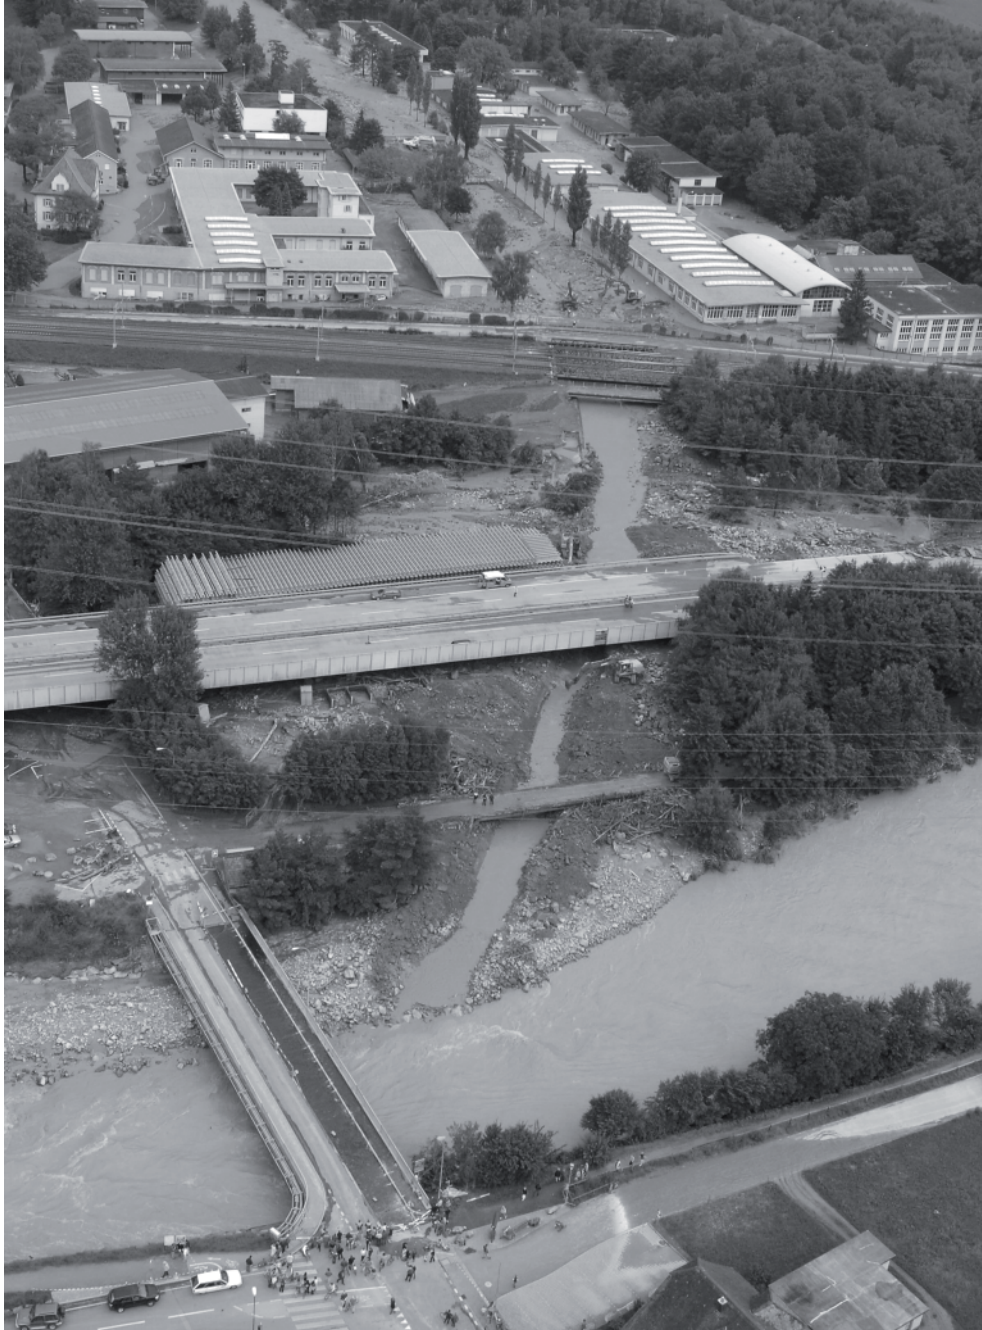
FIGURE 1. Confluence of the Reuss and Schächen rivers after the flood of August 22/23, 2005. The lined masonry channel of the tributary is completely filled with sediment, what caused inundation of the industrial zone in the background (courtesy Canton of Uri)

Figure 1 shows in the foreground the confluence of the Reuss and its tributary, the Schächen river (Canton of Uri, Central Switzerland). This carried a lot of coarse sediment up to stone and block size. This load was almost completely deposited at the confluence, where the main river Reuss was not able to carry all this material away. The deposition then advanced up the lined channel, filling the channel and causing flooding of the neighbouring areas.

In the background of Figure 1 the consequences of the deposition spreading upstream may be seen. The channel was completely filled, and then water and sediment spilt into the neighbouring industrial area. The section below the railway bridge was also filled. A hydraulic jump which occurred about 850 m upstream of the confluence indicated the position to which the deposition front moved upstream. Deposition was as deep as the channel walls in the lower part and about two thirds of the channel depth near the hydraulic jump.

A drainage canal, parallel to the Reuss river and passing in a tunnel underneath the lined channel of the Schächen river, was blocked by sediment spilling from the river channel. The floodplain upstream of the alluvial fan of the Schächen river is lower compared than the beds of both rivers. That is why the tunnel was built. Because of the blockage another big industrial area was flooded for days (located further on the right looking at Figure 1).

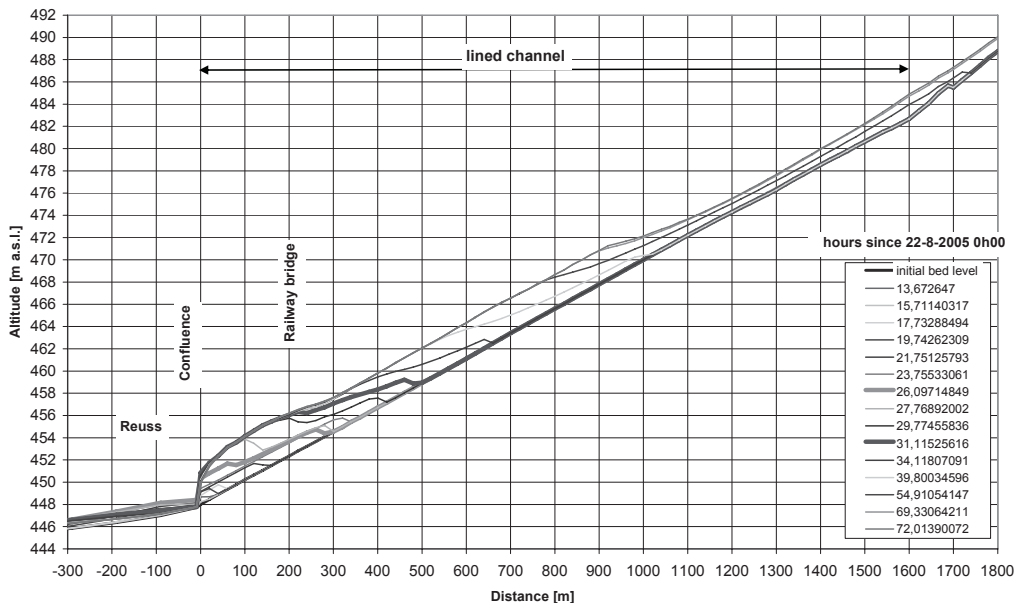
FIGURE 2. Results of the sediment transport simulation in the lowest reach of the Schächen river. Development of the blocking of the flow section near the confluence and upward movement of the deposition front

Figure 2 shows the results of the numerical simulation of sediment transport in the lined channel which forms the lowest reach of the Schächen river about 1.6 km long. The phenomena which were observed during the night of 22/23 August 2005 could well be reproduced. Shortly after midnight the water level in the main river Reuss rose above the side walls of the tributary. This was due to the high discharge in the Reuss river as well

as substantial sediment deposition from the tributary. Consequently, water spilled over the side walls of the Schächen. This produced a sudden deposition of sediment in the last 100 m of the lined channel which blocked completely the flow section. Obviously, the overspilling water reduced the local transport capacity and favoured the blocking of the channel. Over the following hours the sediment arriving from upstream was caught in the blocking and thus a deposition front was moving upstream. Around 07 h 30 in the morning this front had passed the railway bridge. In consequence, water and sediment spilt over both banks into the surrounding industrial area, causing extremely heavy damage. Until the end of the flood, the front moved up about 850 m, marked by a hydraulic jump visible in the after flood documentation.

The simulation was repeated for channel walls which were raised by 1.5 m in the lowest part and the railway bridge being replaced by so-called pressure bridge. With an upstream apron and adapted side walls the flow is forced under the bridge and blocking of the bridge section is prevented (Jaeggi 2007). With this arrangement no spilling over the side walls was observed and no blocking of the section occurred. Therefore, the high water level in the main river which induced overspilling of the side walls in the last reach of the tributary was the main cause of the inundation, since the sudden blocking of the section and the upstream movement of the deposition front finally produced the disaster.

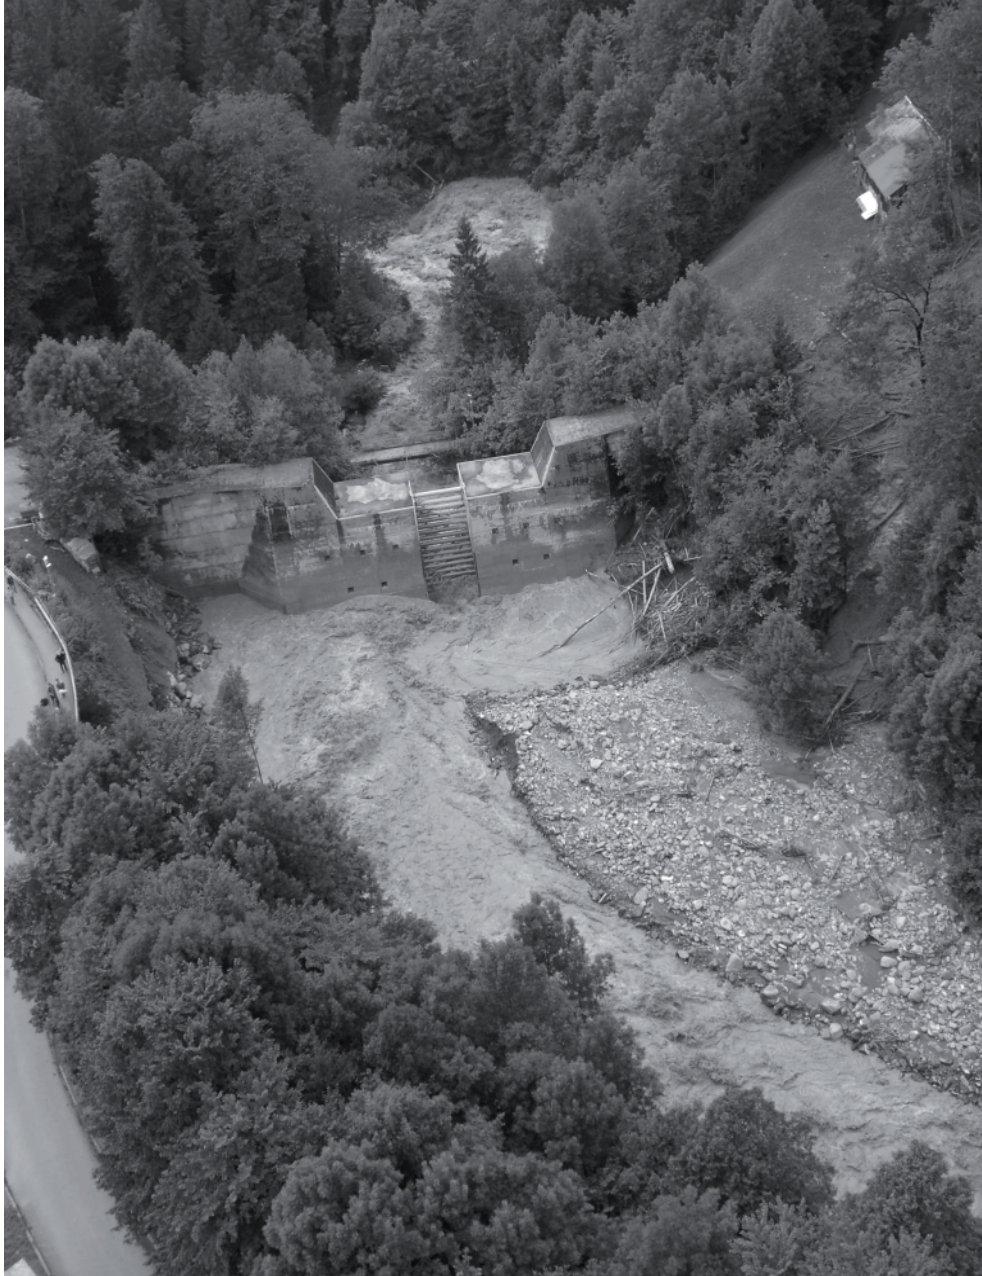
FIGURE 3. Sediment detention basin 'Stiglisbrücke', about 4 km upstream of the confluence, towards the end of the flood. A large part of the deposition visible on the right was flushed later during receding flow (courtesy Canton of Uri)

The performance of the detention basin did however not meet the expectations. Figure 3 shows the detention basin with some deposition, towards the end of the flood. The volume retained behind the dam was far smaller than expected. The water level in the basin was mostly lower than the crest of the overflow section, what is reduced the detention volume. This was partly due to the size of the

bottom outlet, which proved to be larger than in the original design. However, when the design was made it was taken for granted that the bottom outlet would be blocked by floating debris in case of major events. Although this outlet was 3.3 × 4.5 m wide, the trees were sucked by the current through the bottom outlet without blocking it.

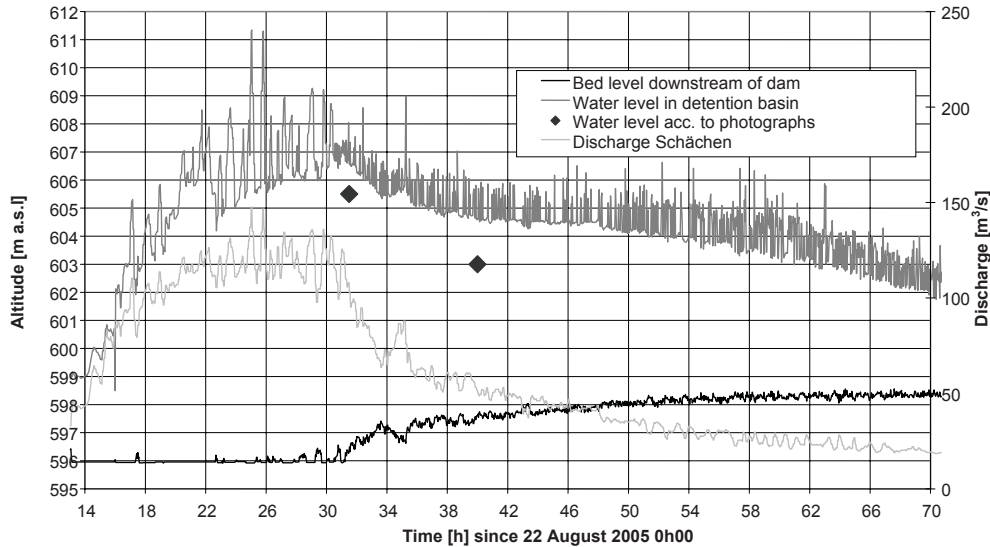
FIGURE 4. Water level in the detention basin and downstream deposition, resulting from numerical simulation

Figure 4 shows the results of the simulation for the basin. During calibration, sediment supply from upstream and the hydraulic characteristics of the bottom outlet were varied until the performance after numerical model was satisfactory, compared to observations. Highly unsteady phenomena like water level oscillations in the basin, resulting from oscillating sediment deposition and erosion in the stilling basin and the outlet section, could be reproduced to some extent. Bezzola (2006) relates even the discharge oscillations to these phenomena. Since the

simulation model reproduces quasi-steady and not unsteady flow conditions, this hypothesis could not be verified.

During the receding limb of the flood, the simulated water level was higher than values taken from photographs. It is believed that this is resulting from the fact that a coarse grain size distribution was maintained for the sediment supply, whereas effectively the grain size distribution may have become finer and finer with decreasing flow.

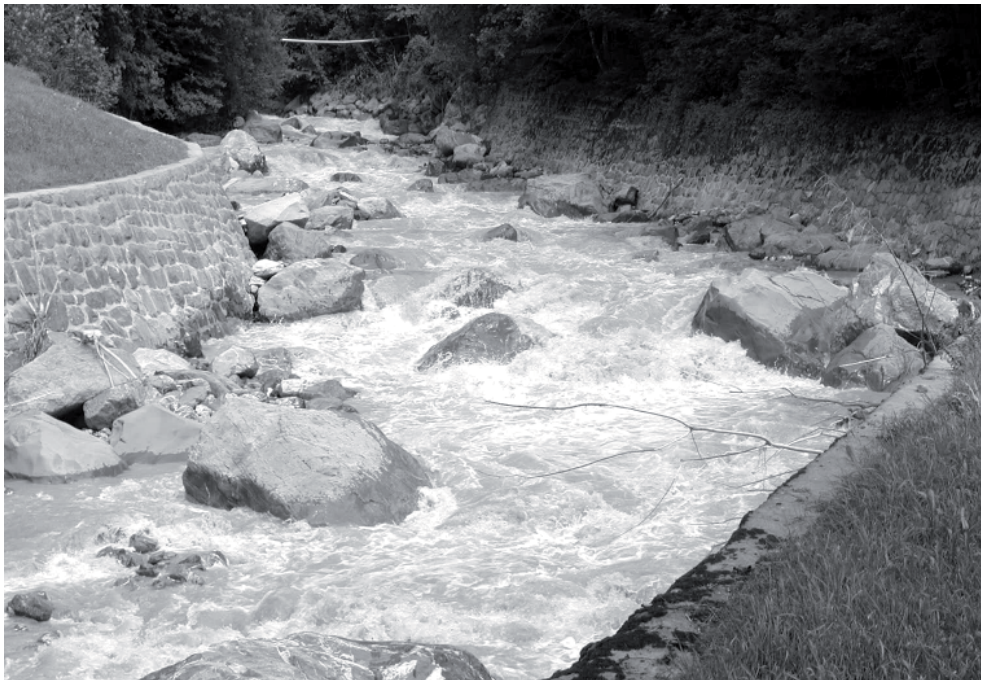
FIGURE 5. Intermediate reach downstream of the detention basin. Despite apparent stability, incision exceeding 1 to 1.5 m occurred

The intermediate reach of the Schächen river between the detention dam and the downstream lined channel exactly presents these characteristics (see Fig. 5). The bed is covered by very coarse boulders and one might expect full stability of the bed. But it was found that general incision occurred which amounted at least to 1 m, sometimes up to 2.5 m. Locally, subsequent bank collapses triggered slides. Totally, about 50.000 m³ were thus supplied to the downstream reach.

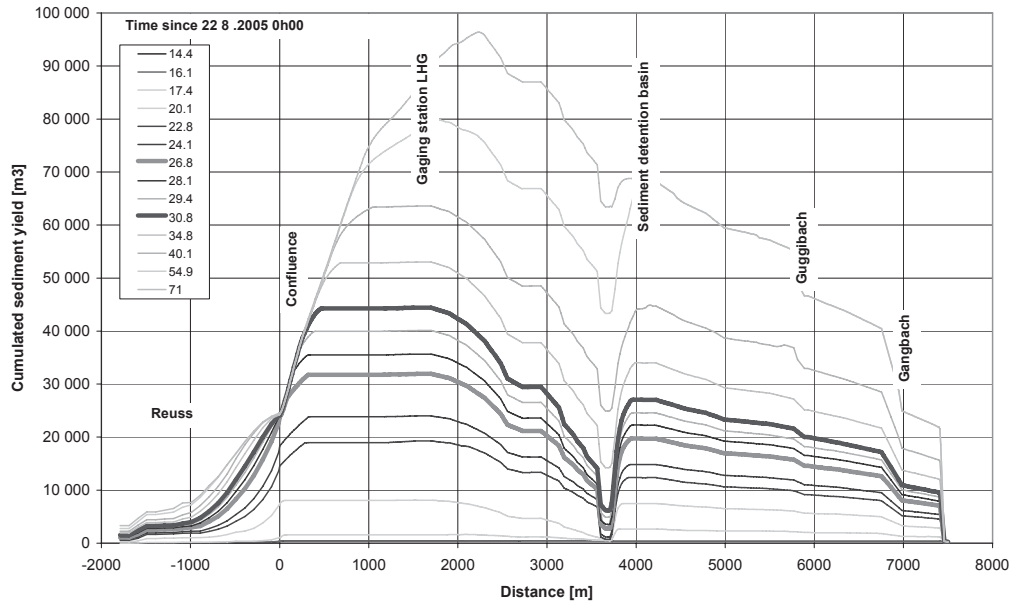
FIGURE 6. Variation of sediment (coarse bedload) transport during the flood of August 2005 in the Schächen river, as calculated by the numerical model

Numerical simulation of sediment transport during the event allowed to give an overall picture of sediment moved as coarse bedload. The results are presented in Figures 6 and 7. Figure 6 shows the cumulated sediment yields along the simulated river reach, Figure 7 the volumes introduced. The red curve represents the moment when water and sediment spilt out of the downstream reach. Simulation is more precise before that moment and more qualitative after that. It can be seen that most of the sediment which contributed to the blocking of the confluence section and the front moving upstream came from the intermediate reach. The detention dam had some positive effect during the first phase of the event, it is only later that the self flushing effect occurred.

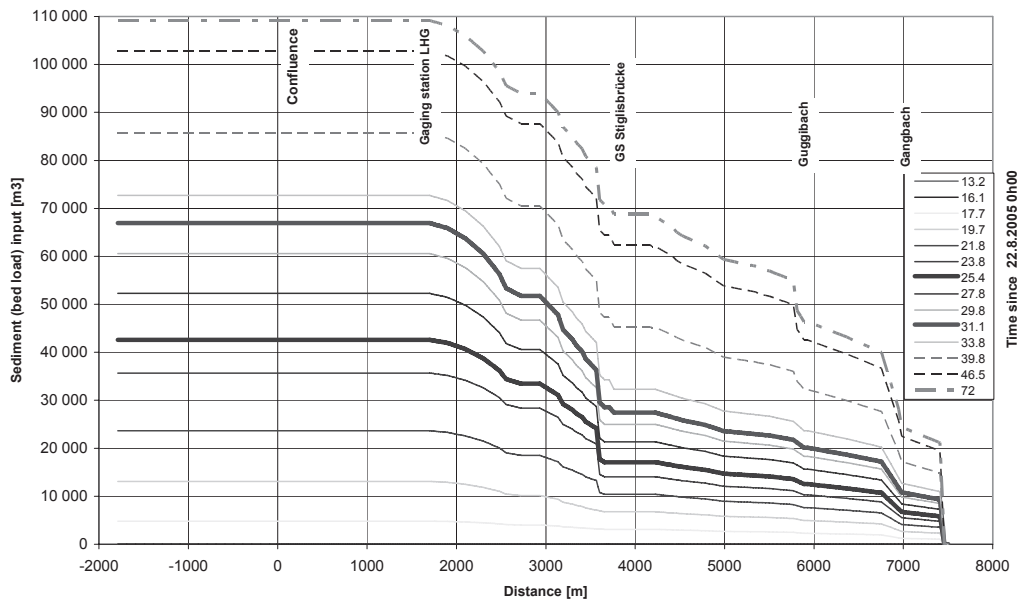
FIGURE 7. Input of coarse bedload material into the Schächen river during the flood event, as calibrated by the numerical model

According to Figure 7, a volume of about 70.000 m³ of coarse sediment was introduced into the system until the moment when large scale inundation started. Over the whole simulation period the volume was about 110.000 m³. These values corresponded reasonably well with the depositions recorded in the Reuss river, in the lined channel of the Schächen and in the industrial areas in the immediate vicinity of the channel. The total volumes cleared from the area where about five times higher, but this material proved to be mainly sand and silt.

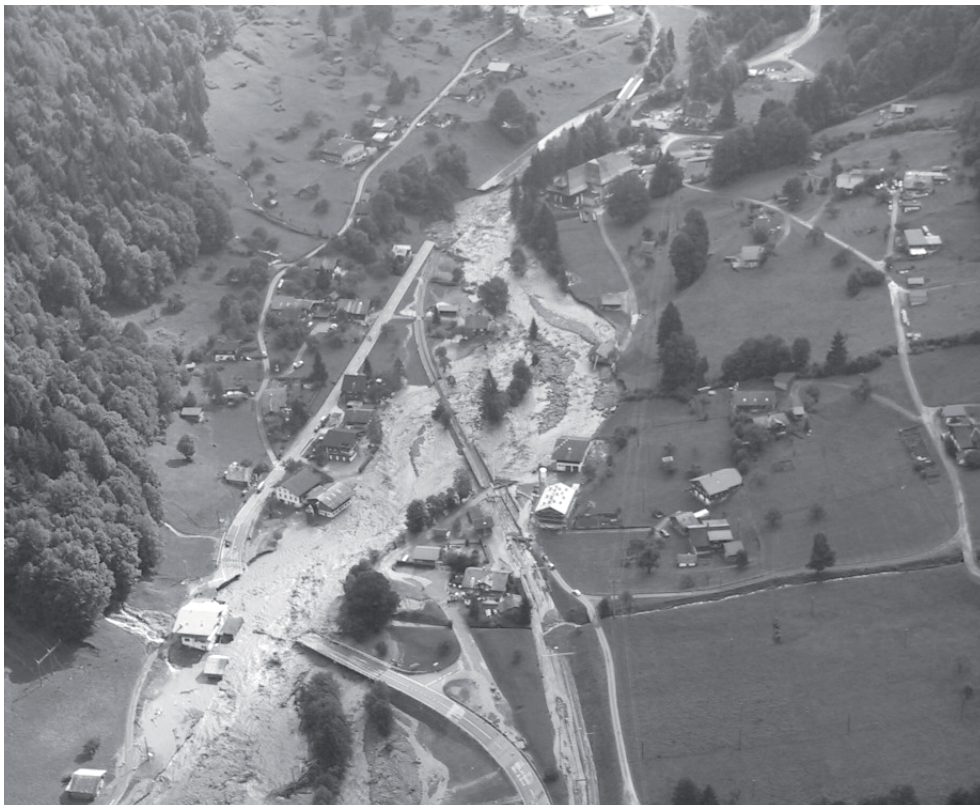
FIGURE 8. The village of Lütshental on the Schwarze Lütshine (near Grindelwald, Canton of Berne). Lateral erosion occurred because of heavy deposition, leading to bridge collapses. Destabilisation of boulder structures in the steeper reach of the background was at the origin of deposition and induced also a strong meander tendency

strong deposition caused flooding and local lateral erosion with subsequent damage. Figure 8 shows flooding in the village of Lütshental. The activation of a meander bend is seen in the background, where the railway and the road leading to Grindelwald were cut. In the foreground a road bridge can be seen, which was destroyed because of general deposition which induced the flow to attack the right abutment. Since this was not deeply founded the bridge collapsed.

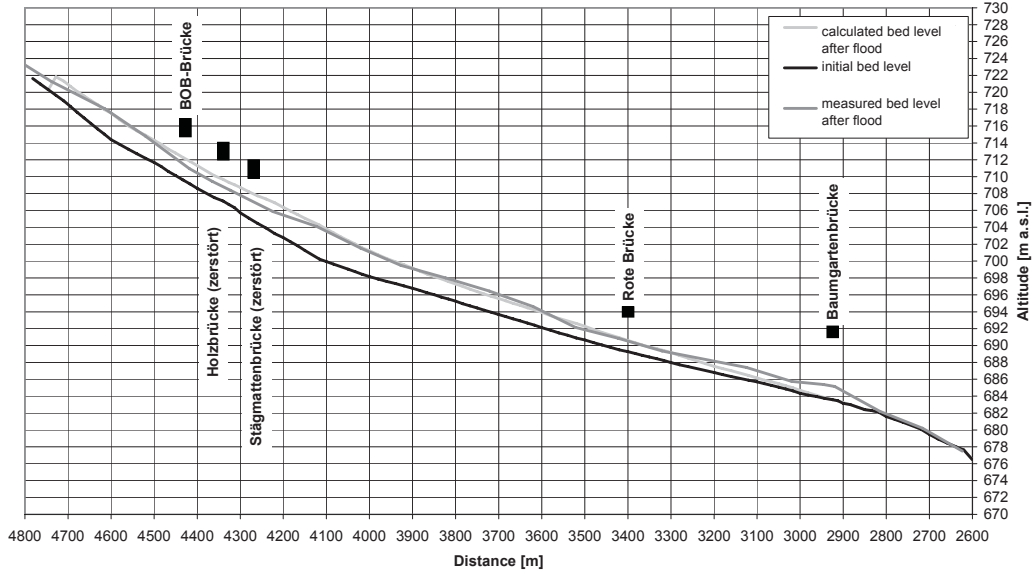
FIGURE 9. Calibration of the numerical sediment transport model in the reach of Lüttschental

As Figure 9 shows, the slope of the river substantially decreases in the village and downstream of it. However, it is not known that during normal floods deposition occurs there. If therefore are really needed the heavy input from the steep reach upstream reach obviously occurs only rarely. A wooden bridge was destroyed in the village of Lütschental which was believed to be about 120 years old. It seems therefore that the discharge during this period was never as high as during the event of 2005, or at least was reached only for a very short duration.

Again a numerical simulation of sediment transport processes was performed. The results are shown in Figures 9 and 10. Reproducing the depositional profile, volume of the input and grain size distribution could be calibrated. The sediment balance illustrated by Figure 10 shows that in such an event most of the sediment mobilised in the upstream reach will be deposited and has no chance to be moved to the downstream reaches. The main goal of the numerical simulation was to

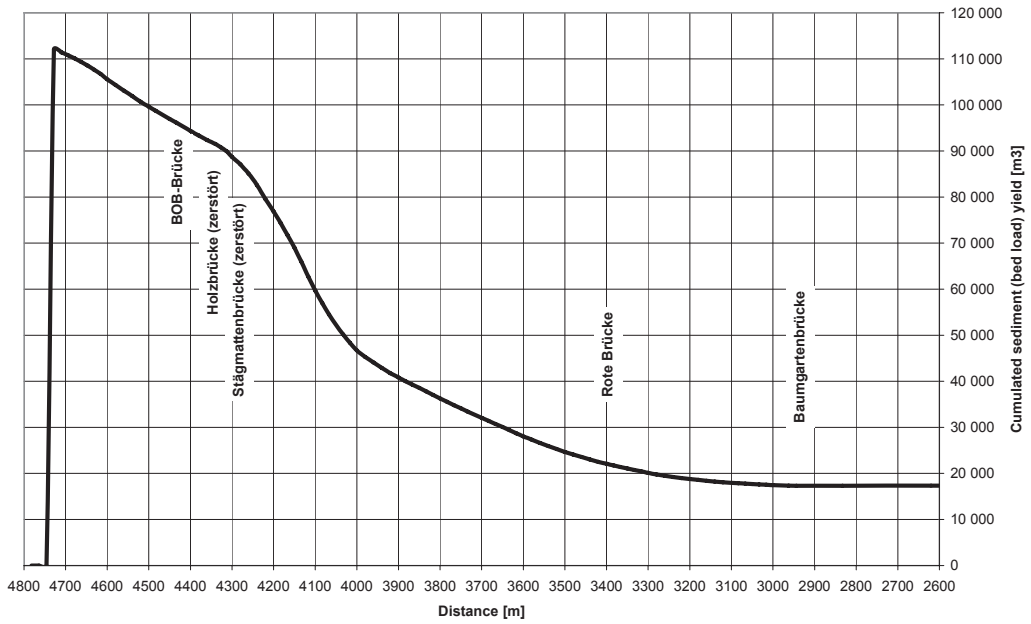
FIGURE 10. Variation of sediment transport, along the Lüttschental reach, resulting from numerical simulation; illustrating the strong deposition tendency during extreme flood events

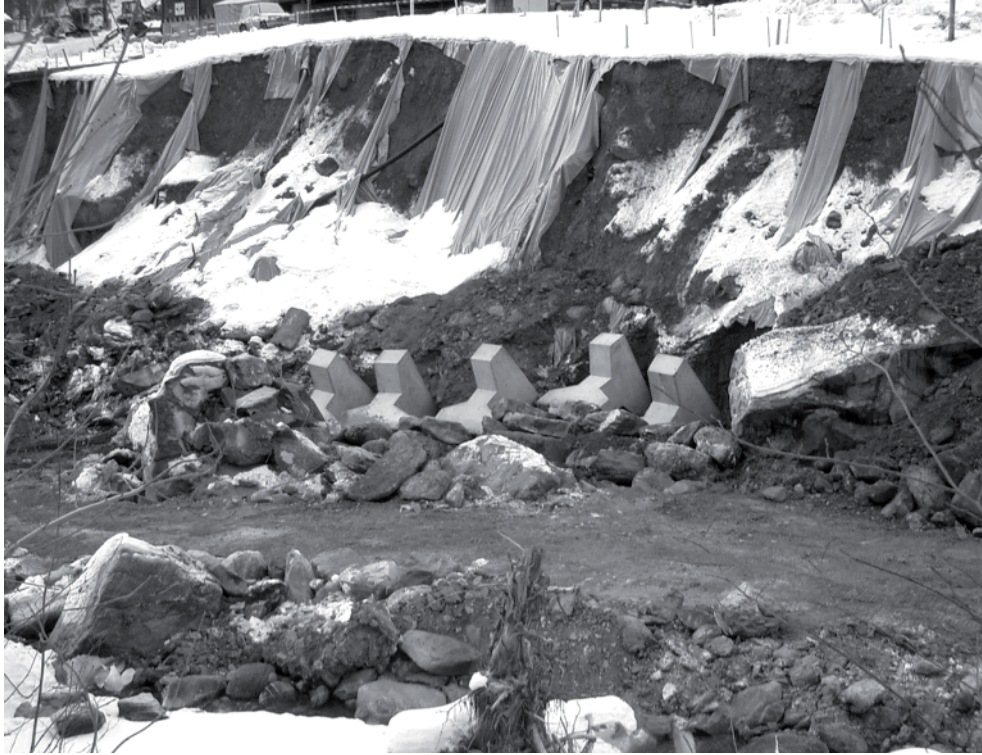
FIGURE 11. Use of heavy concrete polypode elements to increase local erosion resistance, in the steeper part of the Schwarze Lütshine river

For the steep upper reach it was decided to generally accept the new shape of the channel. Local bank protection is set up using heavy concrete elements (see Fig. 11). Such methods have been described by Bezzola (1992 and 2005) or Jaeggi and Philipona (2004). In the potential deposition zones in the village and downstream of it, the river bed will be dredged to the original level. This will be considered to be a depositional area for future events. Since it is believed that only very rare events will actually bring into motion heavy loads of sediment, the threatened areas can still be used by agriculture. Construction of buildings will however be prohibited there. Reconstruction of the road bridge has to consider the deposition process and the flood levels on a deposition while during extreme flood event. Slope reduction will be concentrated in a short reach, where eventual sediment depositions can be monitored and excavated is necessary.
