# World News of Natural Sciences

## Environmental Flood Protection Dikes

### ABSTRACT

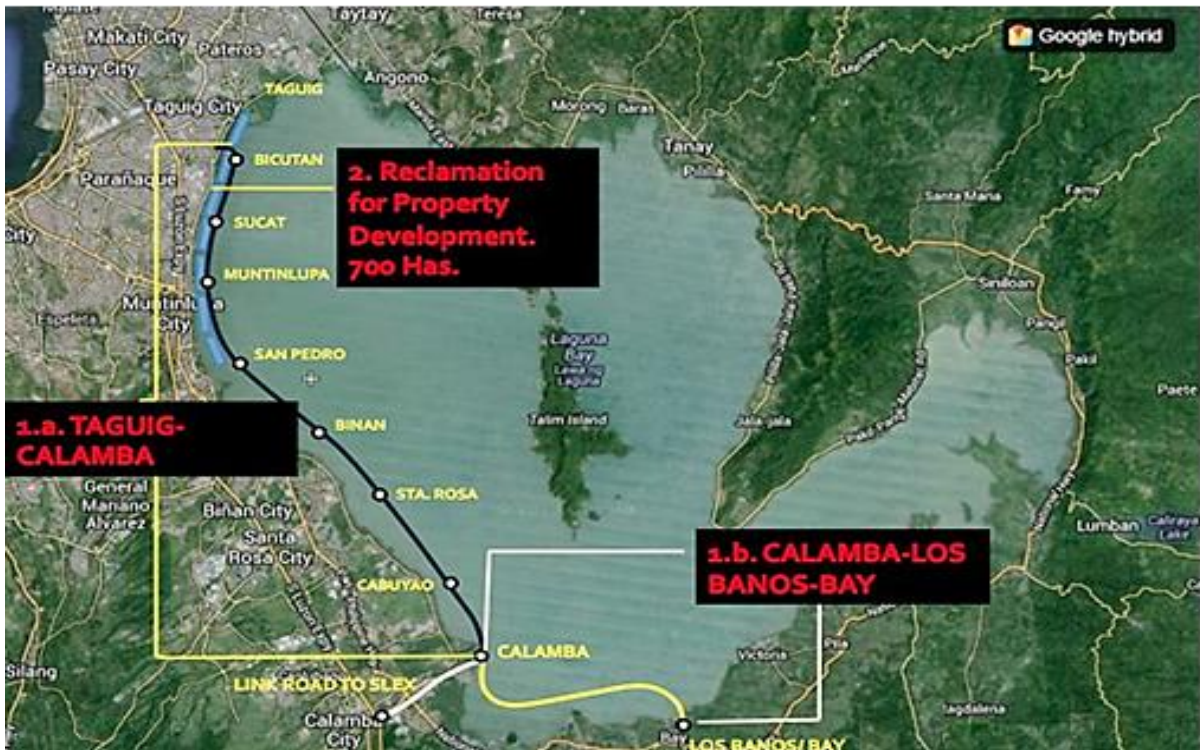
**Figure 2.** Project map of Laguna Lakeshore Expressway Dike

As shown in Figure 2, the route alignment starts from Bicutan, Taguig connecting to the proposed C-6 Expressway Road Project. It traverses southwards passing the city boundaries of Taguig, Parañaque, and Muntinlupa in the southern part of Metro Manila and then continues further south passing the cities of San Pedro, Biñan, Santa Rosa, Cabuyao, Calamba and ends up at Los Baños in Laguna, near its boundary with Bay. The construction of the expressway dike is proposed to involve two sections. These are from Bicutan to Calamba, and from Calamba to Los Baños.

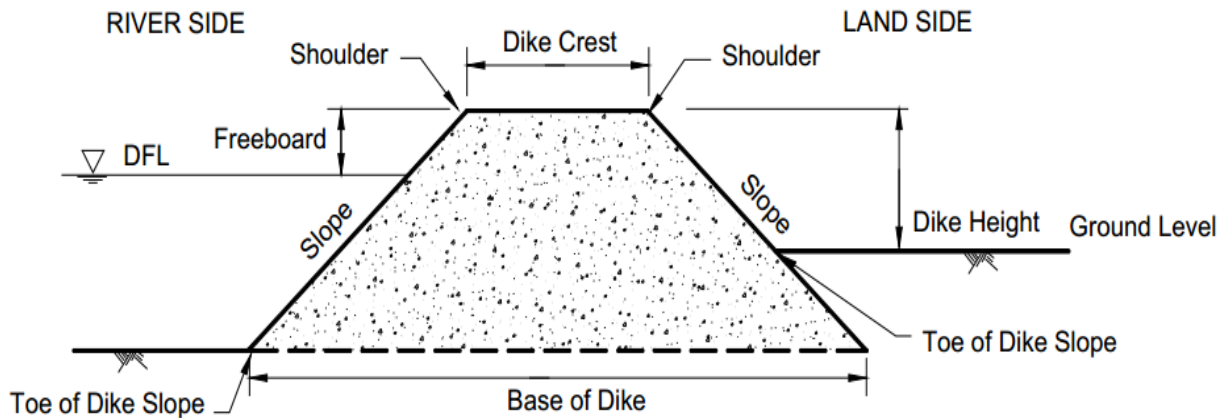
**Figure 5.** Parts of a dike

Dike construction may include new dike and widening or raising existing dike. The new dike shall be designed to protect the affected flood prone areas. In consideration of the stability of the structure, the dike alignment shall avoid unstable peat and muck, weak subsoil, and loose sand foundation to prevent settlement (JICA, 2010). Whenever there is a necessity to heighten/widen the dike on the landside or Riverside, the position depends on the alignment; however, ideally the landside is preferred. When there is a right of way problem or when there is adequate water way, widening may be applied on the riverside. However, when the toe of the dike is close to the low water channel in case of a compound cross section, it is suggested to avoid widening on the riverside even if there is sufficient river width (Renne et. al., 1996). Indeed, as of last November, DPWH is still advocating wholesale reclamation of near shore Manila Bay, as this map from the agency shows. Figure 4 shows the widening and heightening of existing dike while Figure 5 shows the parts of a dike.

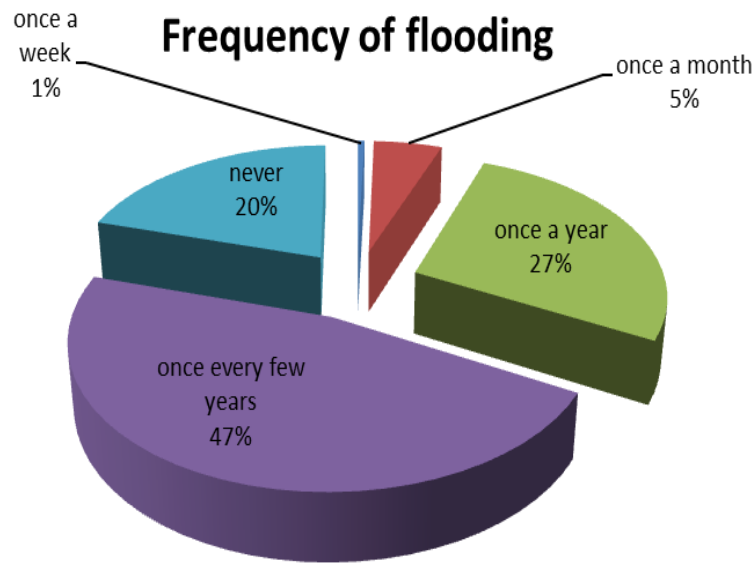
**Figure 12.** Frequency of flooding

Figure 12 shows that, according to respondents, the frequency of floods is between once a week to once every few years, indicating that the chance of inundation is not uniformly distributed even in this small community.

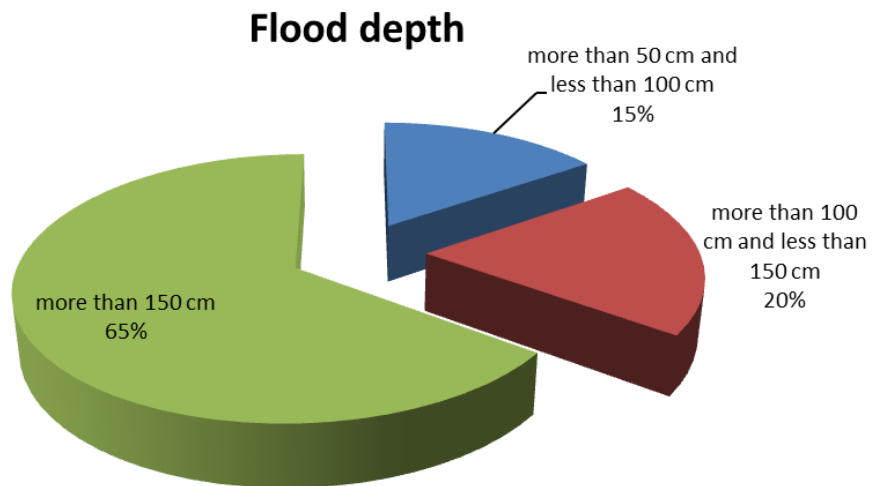
**Figure 13.** Flood depth during the worst flood in their lives

Regarding the most severe flood they had experienced during their lives, 65% of respondents replied that water was 1.5 m deep or more shown in Figure 13. As the researcher had not originally foreseen that such deep inundation was taking place, the questionnaire could not accurately capture the ranges for higher inundations. Nevertheless, some respondents indicated that the flood waters reached up to the second floor of their houses, which would represent a maximum inundation of nearly 3.5 m.
