## The regeneration of the tools to cellulose cutting using electric arc surfacing method

**Abstract:** *The regeneration of the tools to cellulose cutting using electric arc surfacing method.* The paper presents the laboratory results of the regeneration of the tools to cellulose cutting, using electric arc surfacing method. Three types of regenerating material was used in the rod electrodes form. Additionally, each material was applied with additional non-magnetic powder in the coating. Finally, the layer with the highest microhardness was covered with a ZrN coating in the Arc PVD process. The relative wear coefficient, the friction moment, the friction coefficient, the width of friction track and the microhardness were measured. The SEM observations and EDS investigations were applied for the studies of the microstructure of investigated materials. The best results were obtained for the regeneration using regenerating material, marked as “T-590 + powder”, with ZrN coating.

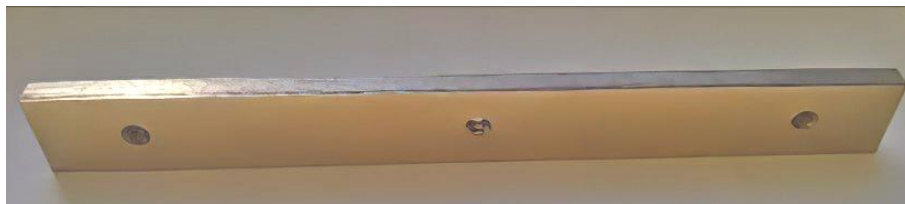
The investigation were provided using NC11 steel tools, with the dimensions of  $6 \times 25 \times 195 \text{ mm}^3$ , presented in Fig. 1, used in the food industry to the cutting of cellulose, used to the candy wrappers. There tools were intended for the Italian production machine of MC Automations company, type MC1DT-T (Fig. 2).

**Figure 1.** The cutting tool used in the investigation

The above described tools worked e.g. on the production line in the confectionery factory in Kharkiv, in the set of 20 pieces, simultaneously. Each tool had 4 edges, used one at a time. The unit cost of the tool, before Russo-Ukrainian war was about 150 USD. Due to the relatively high price, the tools regeneration was attempted, when the wear was about 5 mm per the edge. The regeneration processes were performed at Petro Vasylenko Kharkiv National Technical University of Agriculture Ministry of Education and Science of Ukraine in Kharkiv, using the electric arc surfacing method. The estimated regeneration cost was about 20 USD per piece.

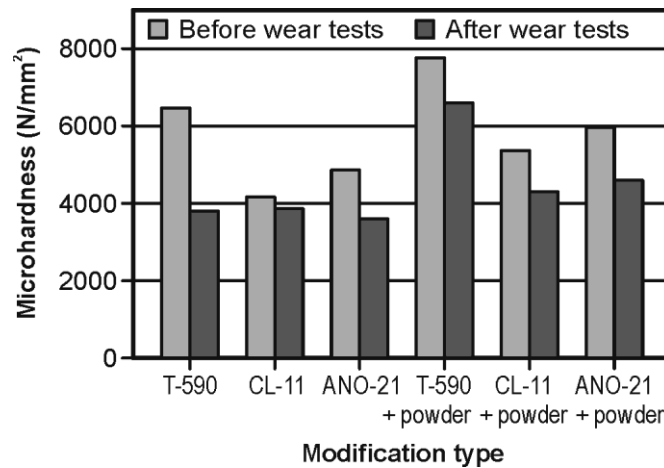
The level of the microhardness, before and after wear tests is an important indicator for evaluating the effectiveness of the restoration and strengthening process. In this case, wear tests were conducted under conditions similar to the real-life operation of the tools. The results of the microhardness measurements before and after the wear tests for all modification types are presented in Fig. 5.

A decreasing of the hardness level was observed after the wear tests for all samples. This may be related to the removing of a finer non-magnetic fraction contributed to the formation of secondary structures, observed on the friction surface of the formed layers (not shown here).

The maximum level of microhardness both before and after wear tests was obtained for the layer formed using “T-590 + powder” electrode, while the observed decreasing of the microhardness for the both “ANO-21” cases, may be related to the observed non-homogeneity of the obtained layers (not shown here).

**Figure 5.** The level of the microhardness, before and after the wear tests
