**Krzysztof SZWAJKA, Tomasz TRZEPIECIŃSKI**

## **THE INFLUENCE OF MACHINING PARAMETERS AND TOOL WEAR ON THE DELAMINATION PROCESS DURING MILLING OF MELAMINE-FACED CHIPBOARD**

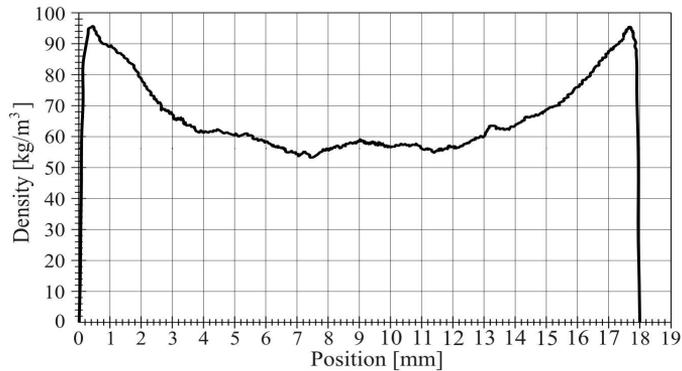
**Fig. 1. Density profile through the thickness of the chipboard measured using a GreCon DA-X instrument**

The measurement of the density profile through the chipboard thickness (fig. 1) was carried out using a GreCon DA-X instrument. The density in the middle part of the thickness was about 85% of the density near to the outer surface layer.

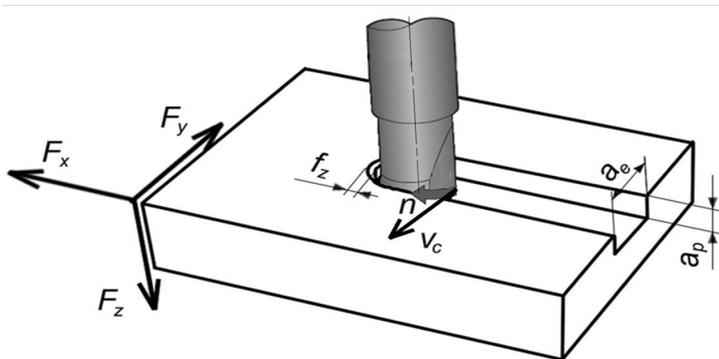
**Fig. 2. Distribution of force components  $F_x$ ,  $F_y$ , and  $F_z$  in the milling process:  $a_e$  – width of milling,  $a_p$  – depth of cut,  $f_z$  – feed per tooth,  $n$  – rotational speed of the milling cutter,  $v_c$  – cutting speed (prepared on the basis of Jemielniak [1998])**

The main objective of the research on the milling process using a high-speed steel tool was to determine the effect of the cutting speed on the cutting tool life. To determine the durability of the cutting tool a geometric criterion was used. As a wear factor the maximum wear of the tool flank  $VB_{\max}$  was adopted. It was decided to determine the influence of the basic cutting parameters (cutting speed, feed rate) on the chipboard surface quality and the value of the signals of the forces occurring in the machining process, i.e.  $F_x$ ,  $F_y$ ,  $F_z$  (fig. 2).

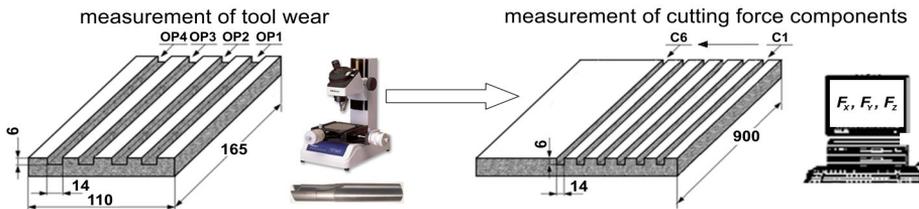
**Fig. 3.** The research method consisted of milling parallel grooves and registration of the cutting forces; tool wear was measured after the end of each operation consisting of six cuts

Before starting the first milling operation using a new tool at  $f_n = 0.2$  mm, the registration of force signals was carried out during one cut (OP1 (fig. 3)). Then, the cutting force components were measured during six cuts (C1-C6 in fig. 3). After the end of each operation consisting of six cuts tool wear was measured. The investigations of tool wear (after one cut) and cutting force components (CFC) during six cuts were carried out on one workpiece. After the registration of cutting forces the tool was dismantled from the spindle and wear was measured. Next, the measurements of cutting forces and tool wear were repeated at  $f_n = 0.5$  mm and  $f_n = 0.8$  mm on a new workpiece, starting with a new tool. An algorithm for experimental procedure is shown in figure 4.

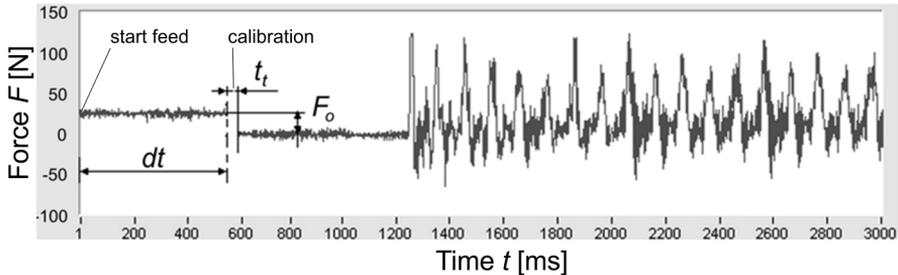
**Fig. 5. Scheme of signal taring for reducing the disturbances in signals recorded by the industrial piezoelectric sensor**

disturbances can be eliminated or reduced by the use of signal taring [Jemielniak 1998]. The method of signal taring of force signals is presented in figure 5. An analysis of the values of the signals started when the feed was turned on by the machine's control system.

After buck-off at time  $dt$ , the average force  $F_0$  acting on a sensor at time  $t_t$  was determined. The average force evaluated was taken as a reference value ( $F = 0$ ). The duration of  $dt$  should be long enough to stabilise forces during tool input. However, the sum of time  $dt$  and  $t_t$  must be shorter than the time of tool input. The cutting force value was evaluated as the difference between the measured force value and  $F_0$  force value.

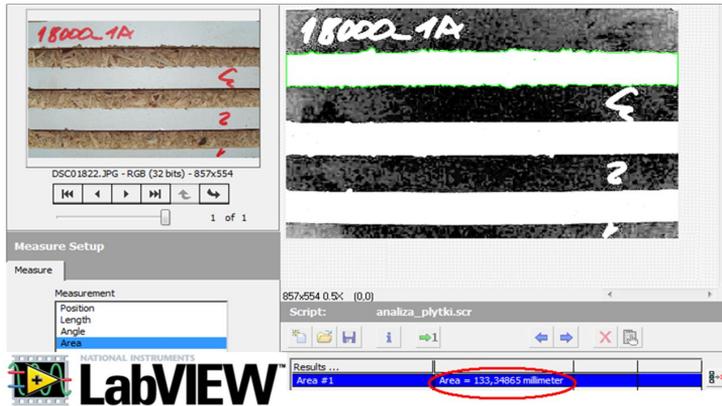
Fig. 6. View of the LabView environment for image analysis of delamination

The maximum wear of the tool flank  $VB_{\max}$  was adopted as a criterion of wear. According to ISO 8688-1:1996 [ISO 1996] the limit value for this wear factor in the case of high-speed steel tools had the value  $VB_{\max} = 1$  mm. In the next stage of the results analysis, in order to determine the effect of wear of the blade, feed and cutting speed on the surface texture, it was decided to analyse the quality of the edge of the chipboard. Based on the digital images of the machined surface obtained during the process of the registration of digital signals of forces, an image analysis of the machined surface was carried out. The digital images were uploaded to a computer, and then subjected to digital post-processing to determine the area of delamination with the Vision Assistant application in the LabView environment (fig. 6).

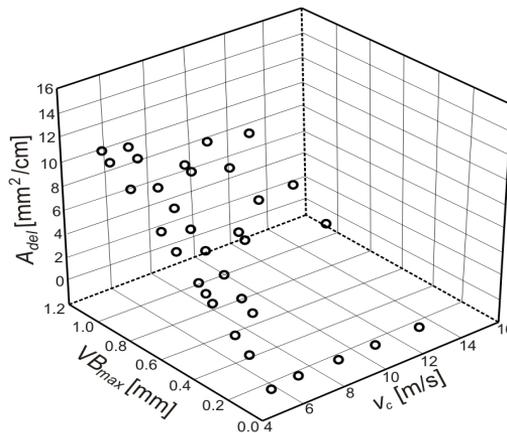
Fig. 7. Effect of  $VB_{max}$  and  $v_c$  on the value of area of delamination  $A_{del}$

With increasing wear of the tool flank  $VB_{max}$ , cutting speed  $v_c$  had a dominant effect on the delamination factor. Increasing tool wear caused an increase in the area of delamination (fig. 7).

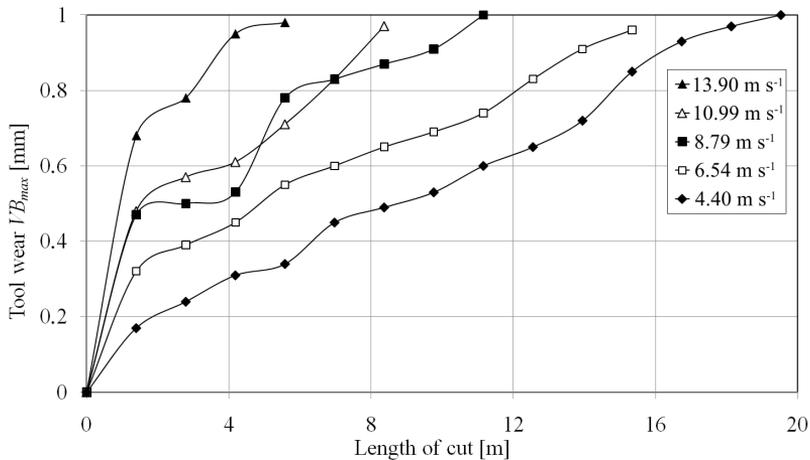
**Fig. 8. Variation of tool wear as a function of cutting distance (for five tools),  $f_n = 0.5$  mm**

Figure 8 shows the variation of wear of the tool flank  $VB_{\max}$  as a function of length of cut  $l_s$  for five tests carried out with different cutting speeds (see table 2). There was a clear impact of cutting speed on the length of tool life and this relation was manifested as a decrease in tool life with increasing cutting speed. For example, the milling cutter machining at  $v_c = 13.9$  m/s after a cutting distance of about 6 metres reached an assumed value of tool flank wear  $VB_{\max} = 1$  mm, and the allowable tool wear of the milling cutter operated at low cutting speed  $v_c = 4.4$  m/s was reached after about 20 metres. Moreover, a rapid increase in tool wear was observed in the initial period of tool operation ( $l_s = 0-2$  m) as cutting speeds increased.

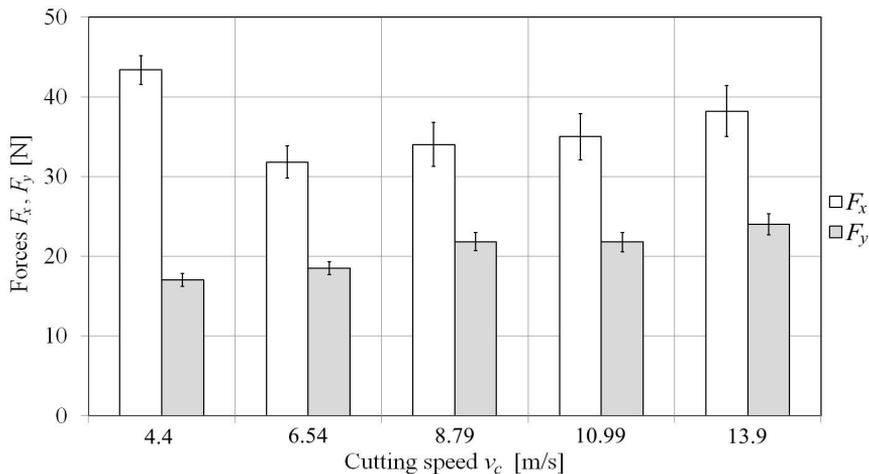
**Fig. 9. Effect of cutting speed  $v_c$  on the value of forces  $F_x$  and  $F_y$**

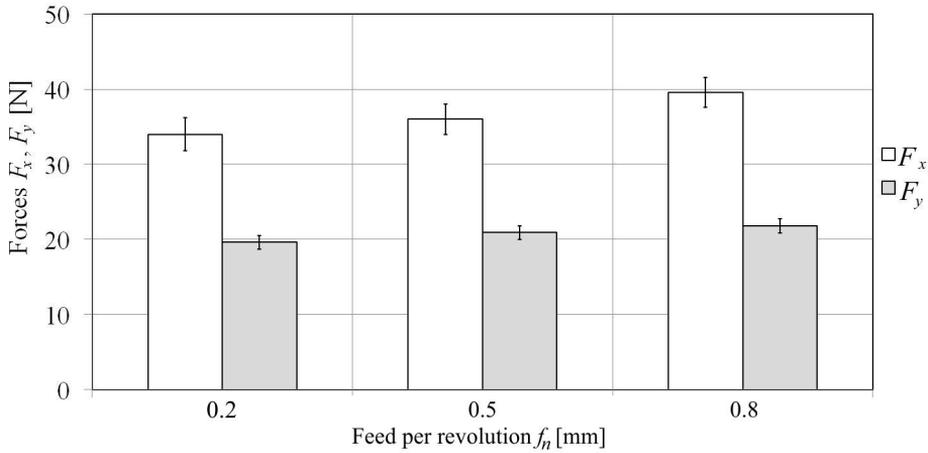
**Fig. 10.** Effect of feed per revolution  $f_n$  on the value of forces  $F_x$  and  $F_y$

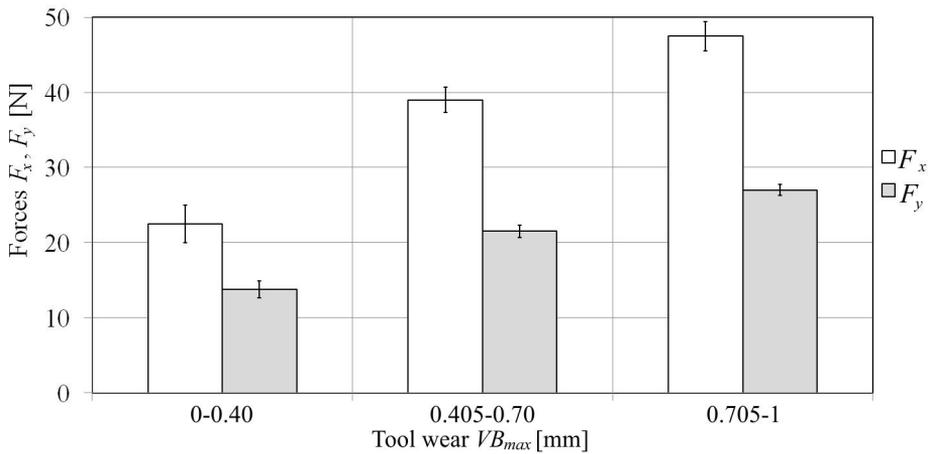
**Fig. 11.** Effect of wear of the tool flank  $VB_{max}$  on the value of forces  $F_x$  and  $F_y$

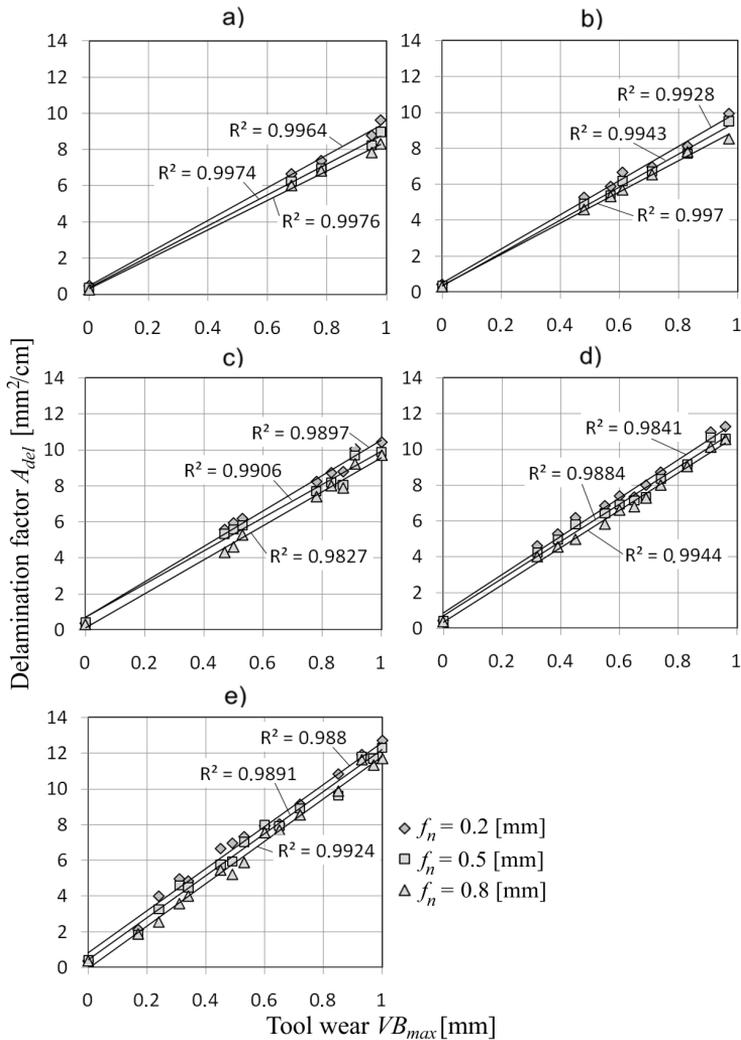
**Fig. 12. Dependence of the delamination factor  $A_{del}$  vs. tool wear for different cutting speeds:  $v_c = 13.19$  m/s (a),  $v_c = 10.99$  m/s (b),  $v_c = 8.79$  m/s (c),  $v_c = 6.59$  m/s (d) and  $v_c = 4.40$  m/s (e)**

Figure 12(a-e) presents the relationship between the delamination factor  $A_{del}$  and tool wear  $VB_{max}$ . A reduction in the cutting speed increased the area of delamination, leading to an increase in the value of the  $A_{del}$  factor. The same conclusion was drawn by Gaitonde et al. [2008b], who has found that by employing a higher cutting speed it was possible to reduce the tendency to delaminate during drilling.
