The species of wood in constructions of six historic churches in Mazovia region

Abstract: *The species of wood in constructions of six historic churches in Mazovia region.* The paper is a continuation of the research of timber species in temples of Mazovia area. Wood samples have been taken from 3 parish churches and 3 cemetery chapels: 1 object of the seventeenth century (Zakrzewo Kościelne), 3 objects from the eighteenth century (Rębertów, Lutkówka and Zambrów) and 2 buildings from the nineteenth century (Białynin and Brańszczyk). All objects were built of pine. In the churches in Zakrzew and Rębertów, were found connecting elements of oak. In other objects lack was access to connecting elements, so not sampled. In the chapel in Białynin is a gothic portal with oak, moved from defunct church in this village. In the chapel in Brańszczyk the painting "Adoration of the 3 Kings" was found on the top backside of the altar, from defunct church in the village. Chapel in Zambrów is known for wall paintings: "dance of death" and illusionist altar. On the roof construction in the church in Rębertów were found little birch wood dowels, as in the church in Boczki. The dowels were fitted pro

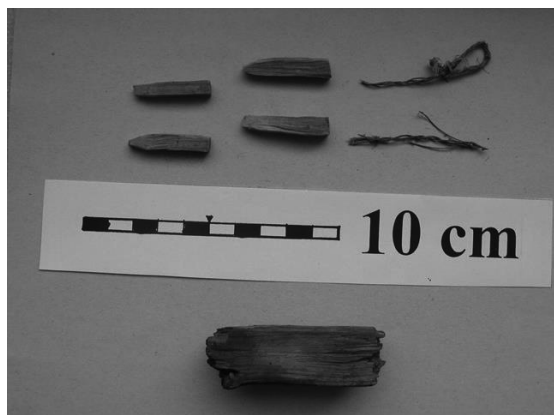
Fig. 1. Small pegs (*Betula sp.*) from the roof structure elements in Rębertów church (open) and peg (*Quercus sp.*) from roof structure in Zakrzewo Kościelne (under)

Note: pins connecting the pillars in the nave of the struts: **2 x *Quercus sp.*** [Fig. 1]

Note: small pegs driven into the roof structure elements **6 x *Betula sp.*** [foto 1]

The small pegs driven into the roof structure elements of church in Rembertów [Fig. 2] were intended for wisps of straw or dried herbs. This is indicated by a thick linen thread that is stored on one of them [Fig. 1]. The wood in these small pins is birch. Until now these small pins for drying herbs were found in the construction of the roofs of churches in the Boczki in Mazovia Province (Krajewski 2012) and other churches (Mączyński 2010).

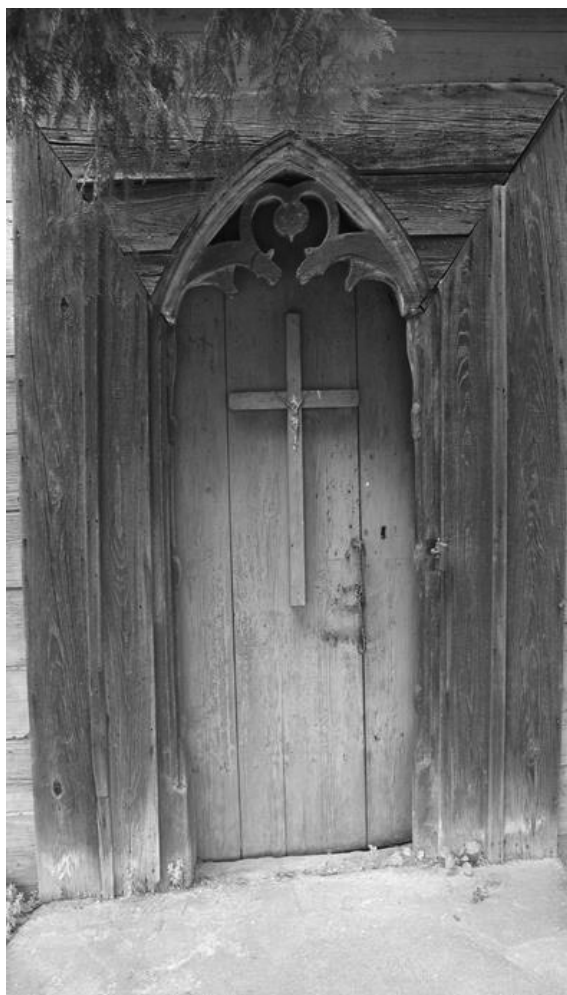
Fig. 3. The Gothic portal (*Quercus sp.*) in chapel in Bialynin transferred from the defunct parish church

Białynin XIX c., cemetery chapel *in situ*, the original walls and roof construction, the Gothic portal transferred from the defunct parish church [Fig. 3]

All major components in all the churches and chapels were made from Scotch pine wood. Oak wood was in non-original new foundations in the church in Zakrzewo Kościelne, in Gothic portal in chapel in Białynin [Fig. 3] in pins in roof structure in churches in Rębertów and originally in Zakrzewo Kościelne. In Zakrzewo Kościelne was found only one preserved remnant of the pin of original roof structure [Fig.1] ch has been replaced with a new construction. The original pins in roof structures older than the nineteenth are made from Scots pine wood.

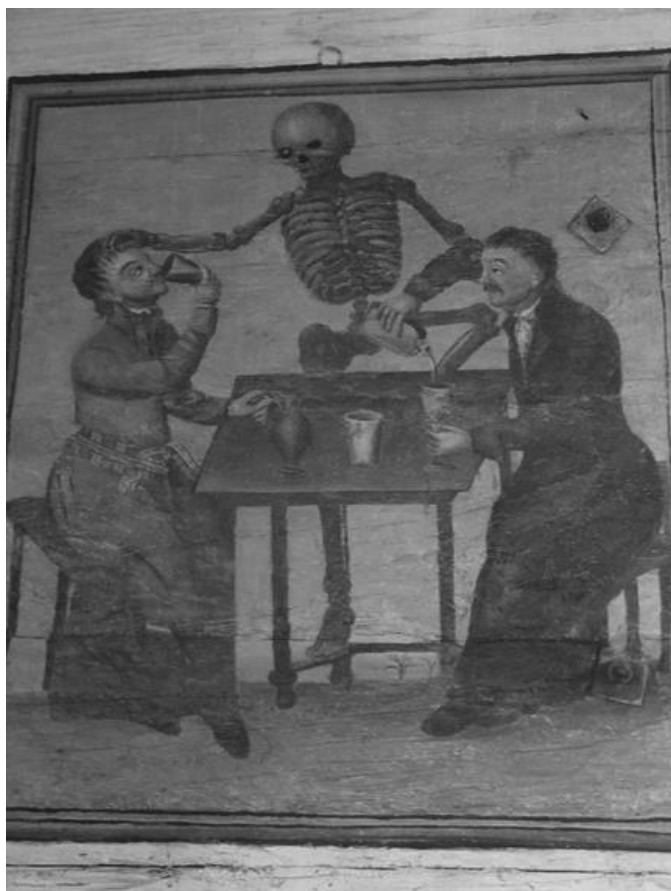
Fig. 4. The paintings of “dance of death” on the walls (*Pinus sylvestris*) in chapel in Zambrów

Chapel in Zambrów is very similar to the later chapel in Brok (Krajewski 2012). The chapel in Zambrów as opposed to the chapel in Brok, however, has beautiful polychrome inside walls [Fig. 4] paintings include illusionist altar and the “dance of death”. The chapel was built on the initiative of Father Marcin Krajewski in 1795. Crest of founder is above the door of chapel.

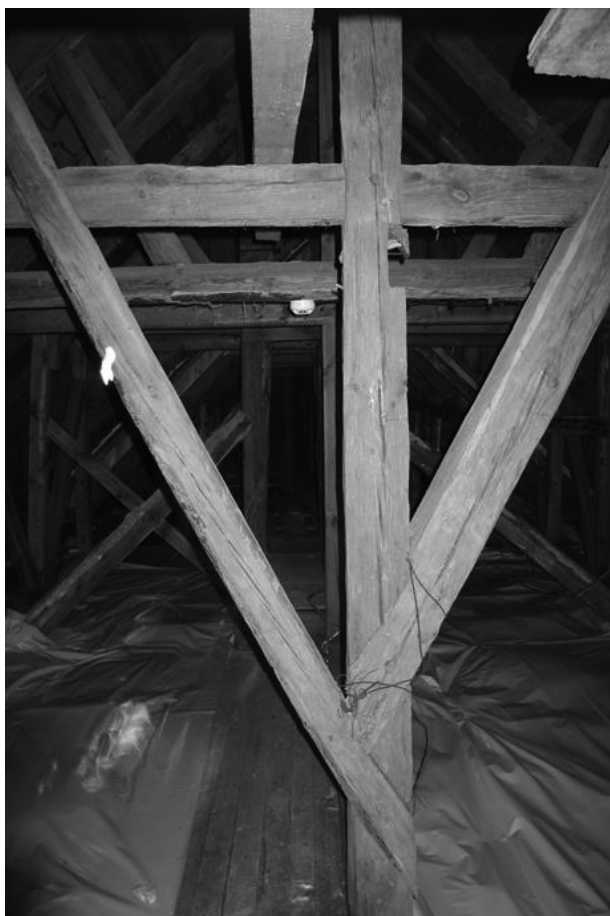
Fig. 2. Part of original roof structure in churches in Rębertów

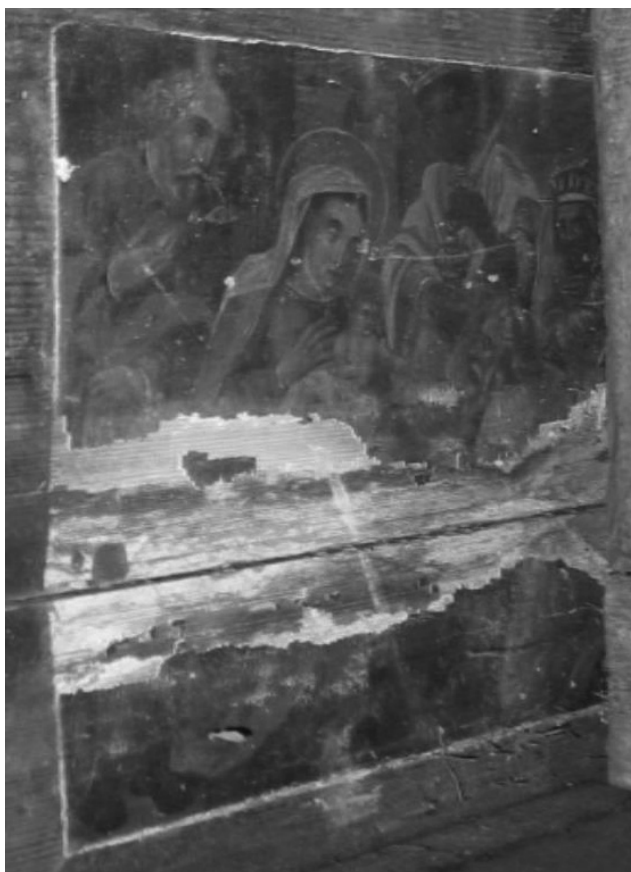
Fig. 5. The unknown paintings of the eighteenth century under the table top (*Pinus sylvestris*) of the altar in chapel in Brańszczyk

During the vetting chapel in Brańszczyk found previously unknown paintings of the eighteenth century under the table top of the altar [Fig. 5]. The paintings come from the eighteenth-century church demolished in 1833.
